R5-TP-026b

# Home Destruction Examination

## Grass Valley Fire

Lake Arrowhead, CA

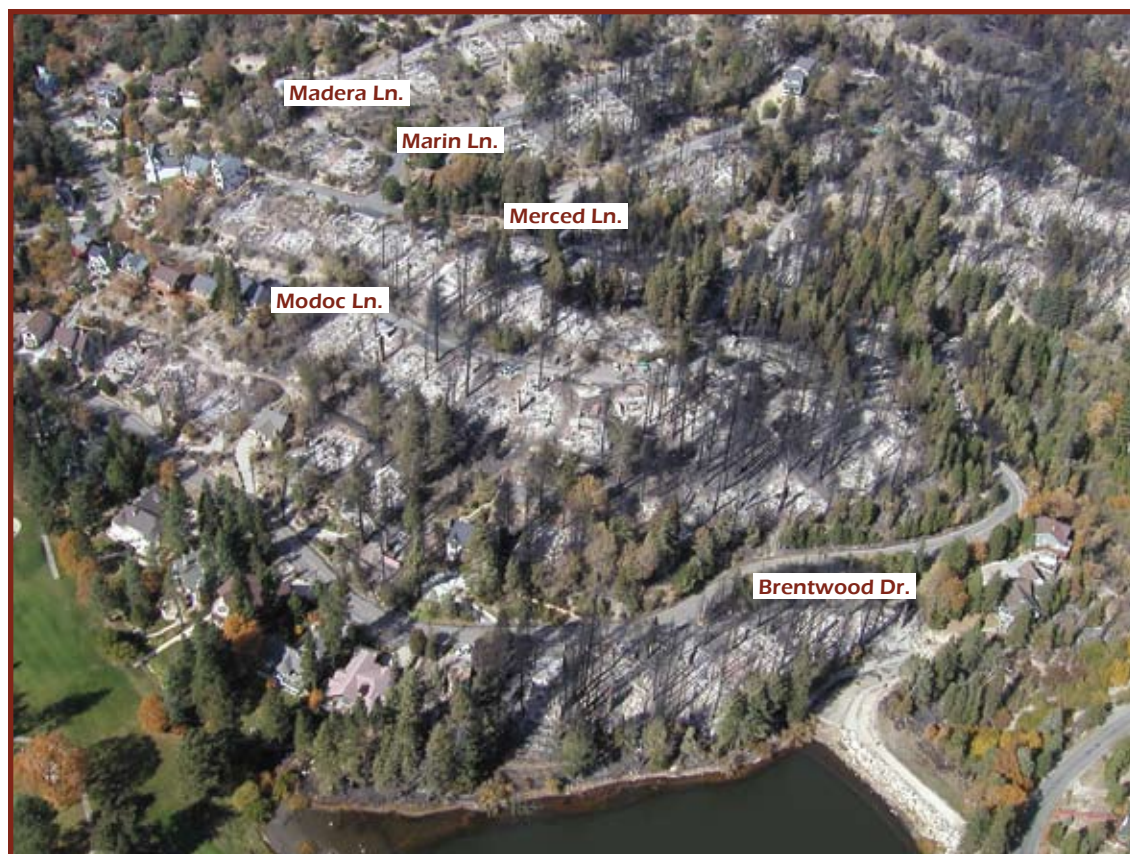
**Figure 4.** Aerial view of home destruction looking northwest. Grass Valley Lake is in the foreground and Lake Arrowhead Country Club is to the left.

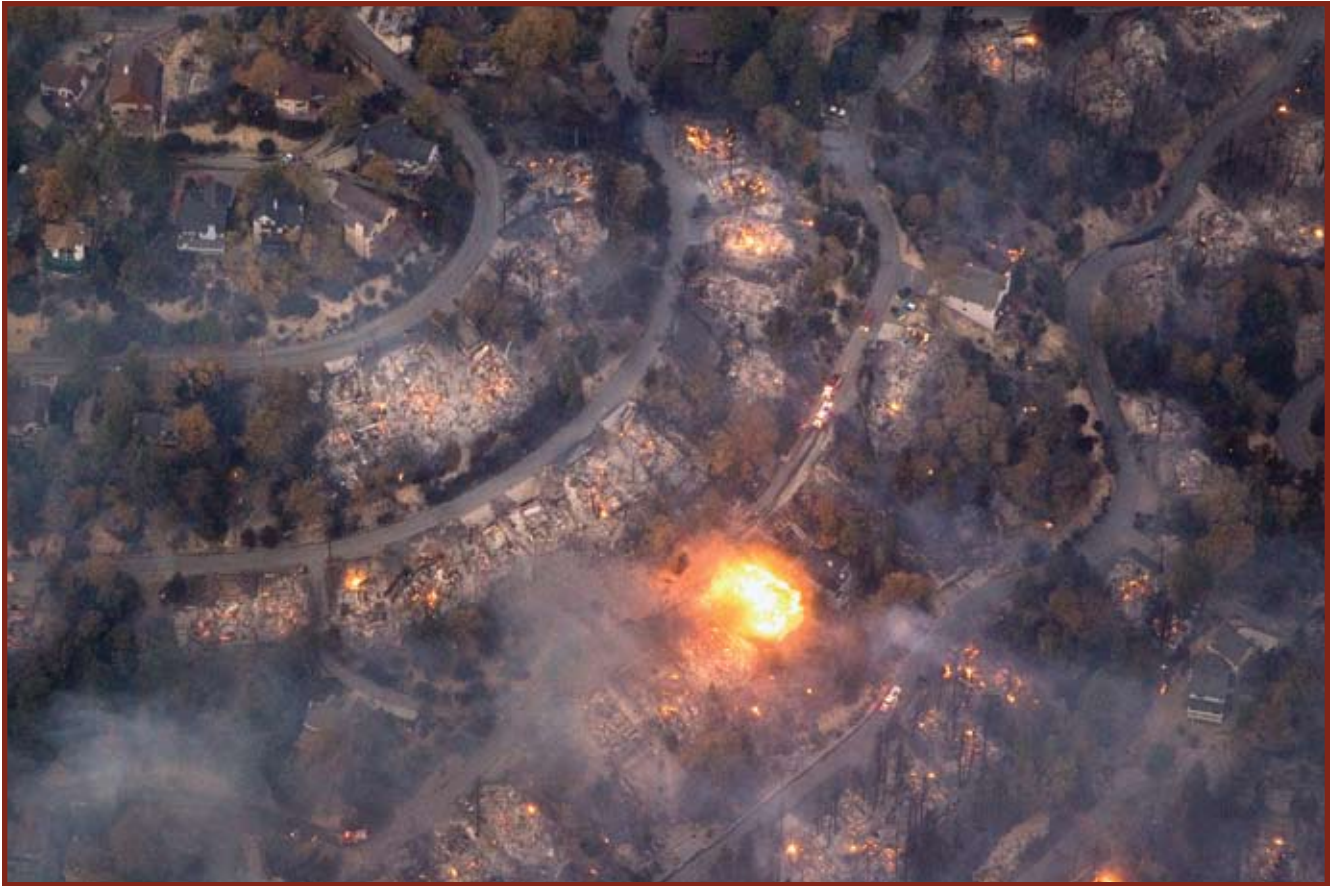
**Figure 5.** A home on Madera Ln. fully involved approximately seven hours after the wildfire impacted the area.  
(Photo taken at 1715 by Don Kelsen, Los Angeles Times)

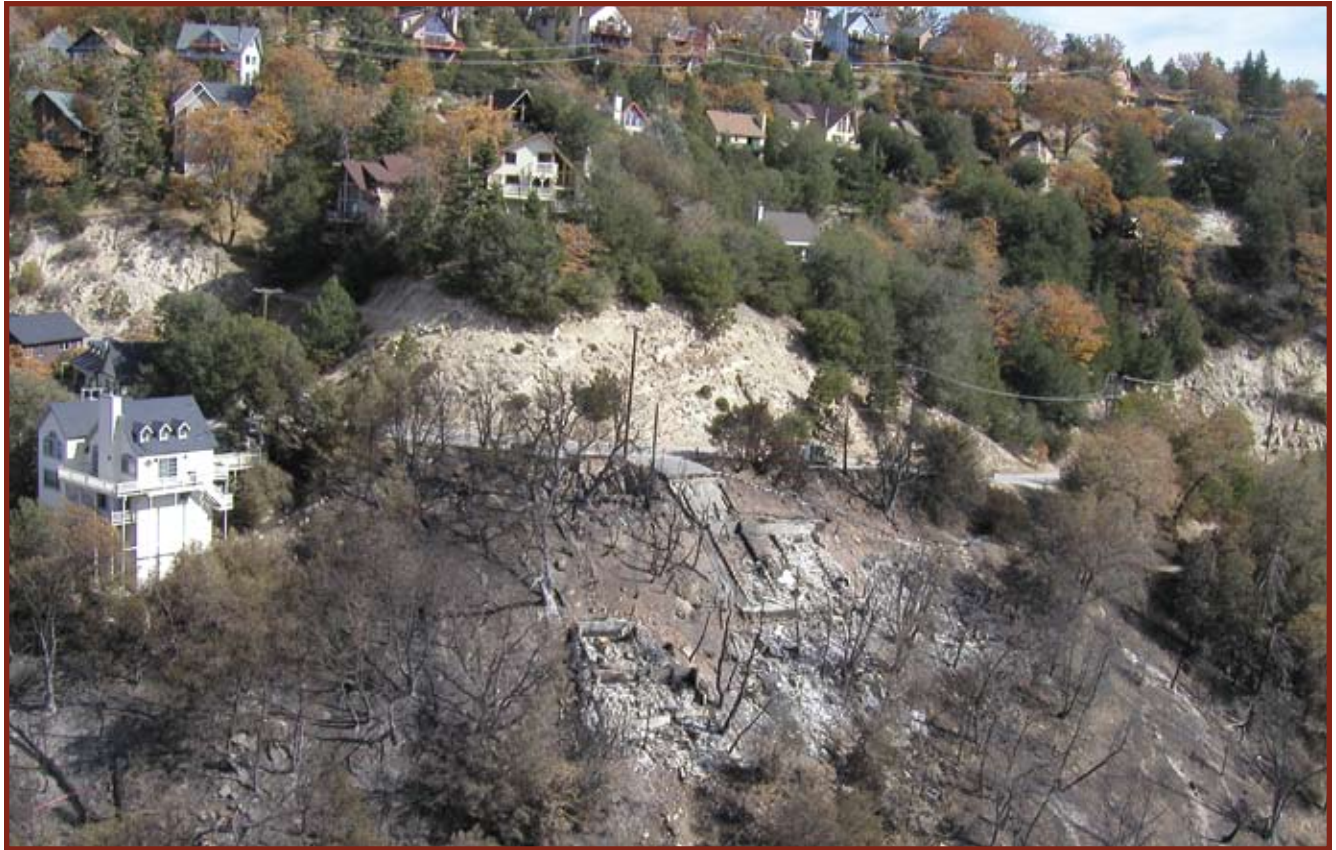
**Figure 6.** Aerial view of homes 1204, 1210, and 1216 off Brentwood Dr. The manzanita and oak canopies remain unconsumed near where conifers torched, suggesting a mixed intensity. The steep slopes (~40°), cross-slope winds, multi-level construction (e.g., four-story home to the left), and close home proximity promote house-to-house spread. This is an example of overlapping HIZs

The east flank of the Grass Valley Fire progressed upslope and into homes located on Edge Cliff and Brentwood (See Figure 1). Fire intensity was moderate to high (shrub and single/group tree torching) (Figure 6).

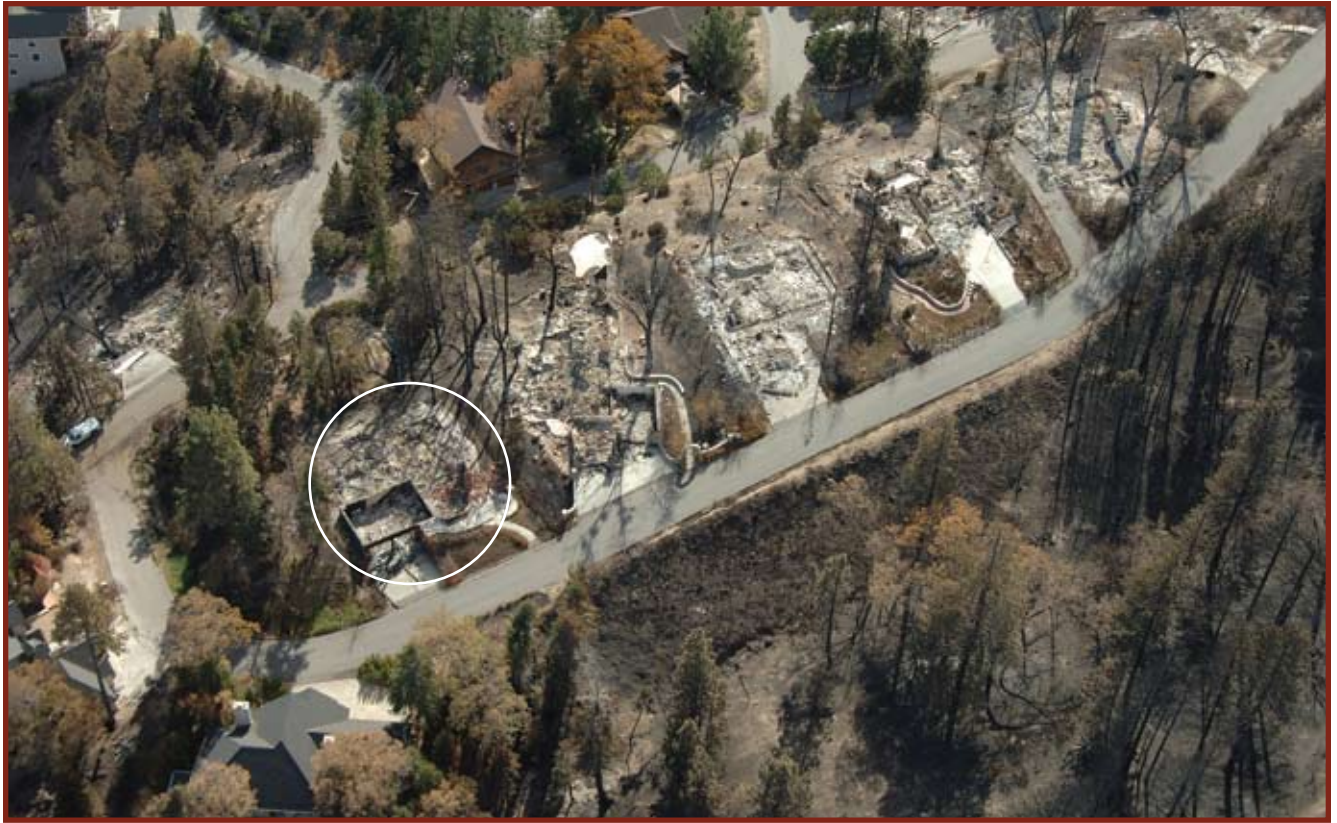
**Figure 9.** Aerial view of home destruction on Windward Rd. Note the unconsumed vegetation around the two homes in the lower left and directly across to the destroyed home (circled). These three homes were exposed to surface fire and/or firebrand(s). Once burning (circled), the house-to-house fire spread continued to neighboring homes. This is an example of a burning home well within a neighboring home's HIZ. (Photo by Tom Iraci)

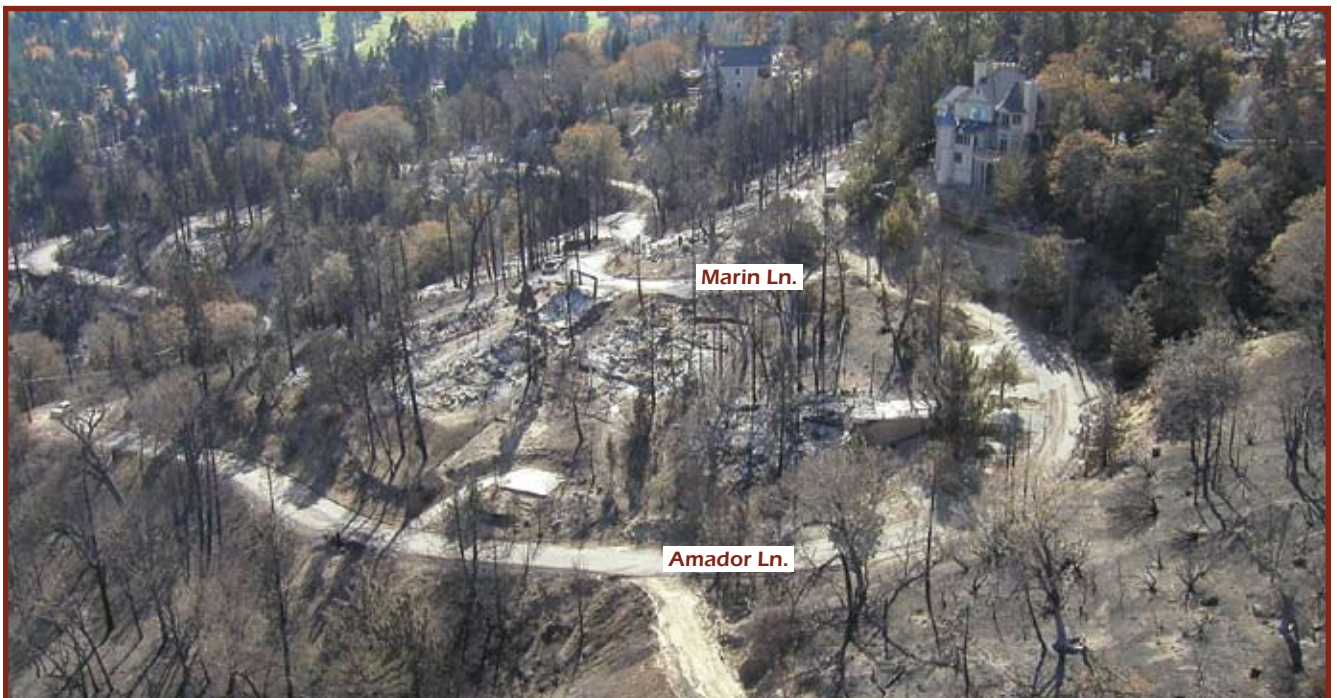
**Figure 10.** An aerial view of home destruction looking south toward Lake Arrowhead Country Club.

Pushed by northerly winds gusting to 30 mph (per Rock Camp RAWS), the head of the Grass Valley Fire progressed southwest through the Grass Valley drainage and upslope into homes located on Windward (Figures 7-9), Amador (Figure 10), Marin (Figure 10), and Trinity (Figure 11).

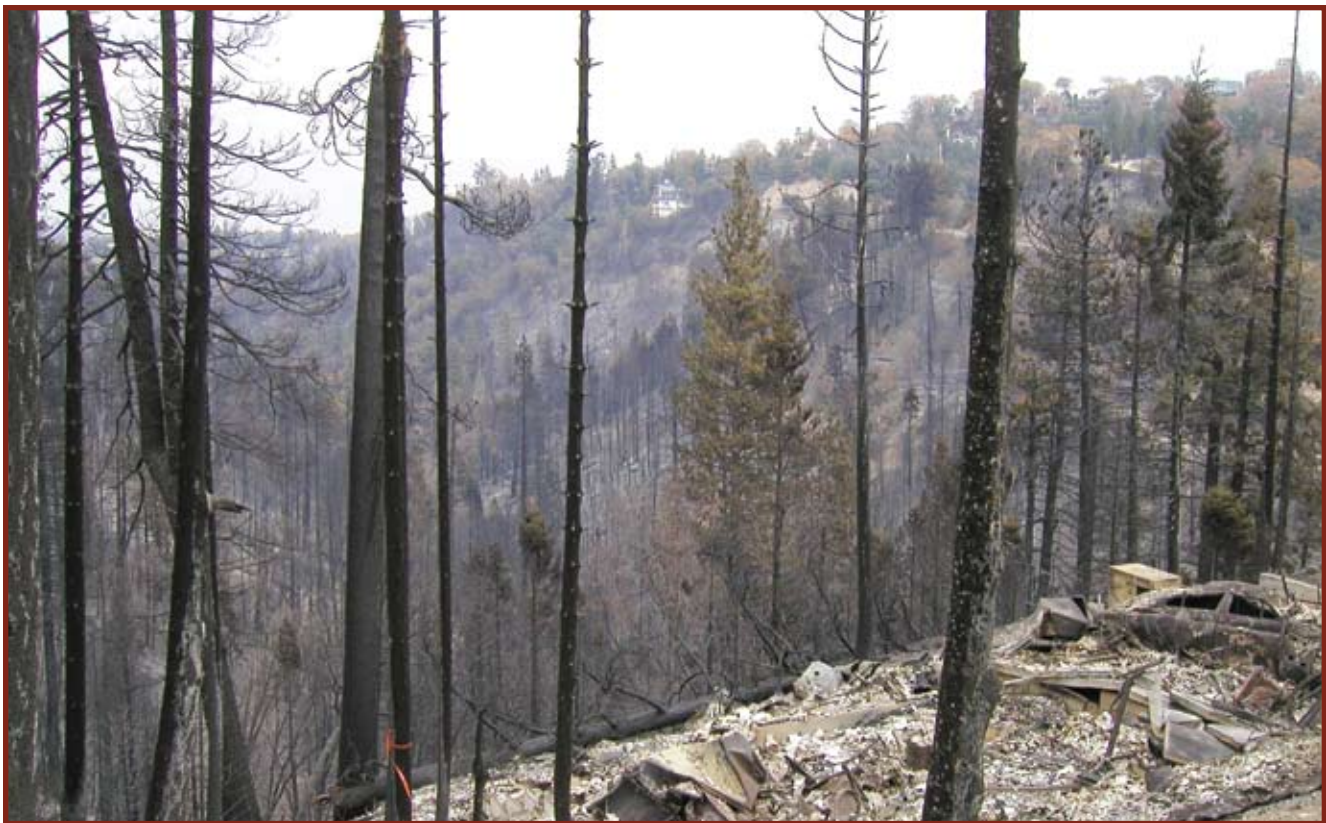
**Figure 11.** A destroyed home on Trinity Dr. looking northeast across Grass Valley drainage; Brentwood Dr. is in the upper right. This photo shows the patchiness of aerial fuels exposed to high wildfire intensities.

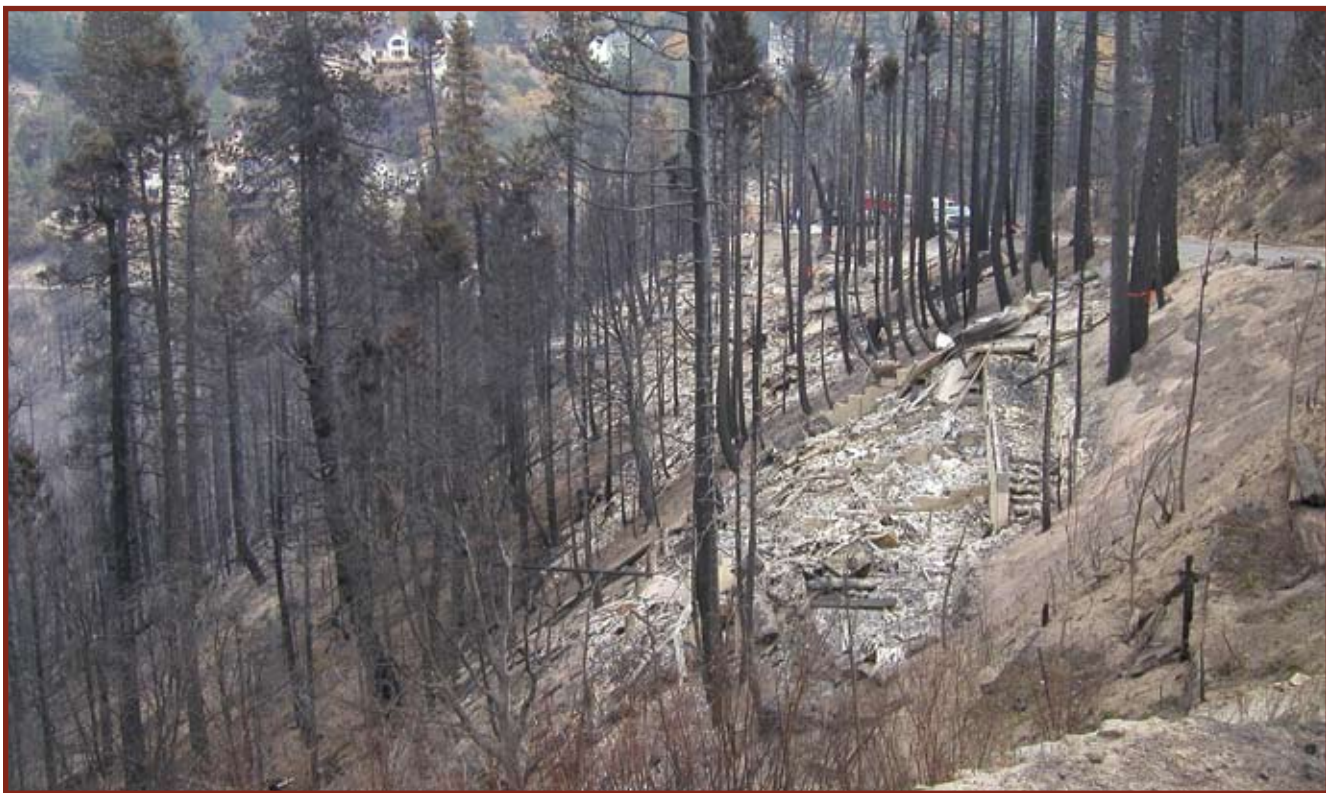
**Figure 12.** View to the east, principally of five destroyed homes on Trinity Dr. (971-949). The high degree of consumption of tree and shrub foliage downslope from these homes likely indicates high intensity flame exposure.

Fire intensity was locally high due to burning shrub canopies and low to mid-height conifer branches, single/group tree torching, and localized crown fire runs. Homes on Windward were impacted first and predominantly exposed to firebrands; homes on Trinity were exposed to the highest flame intensities (Figure 12).

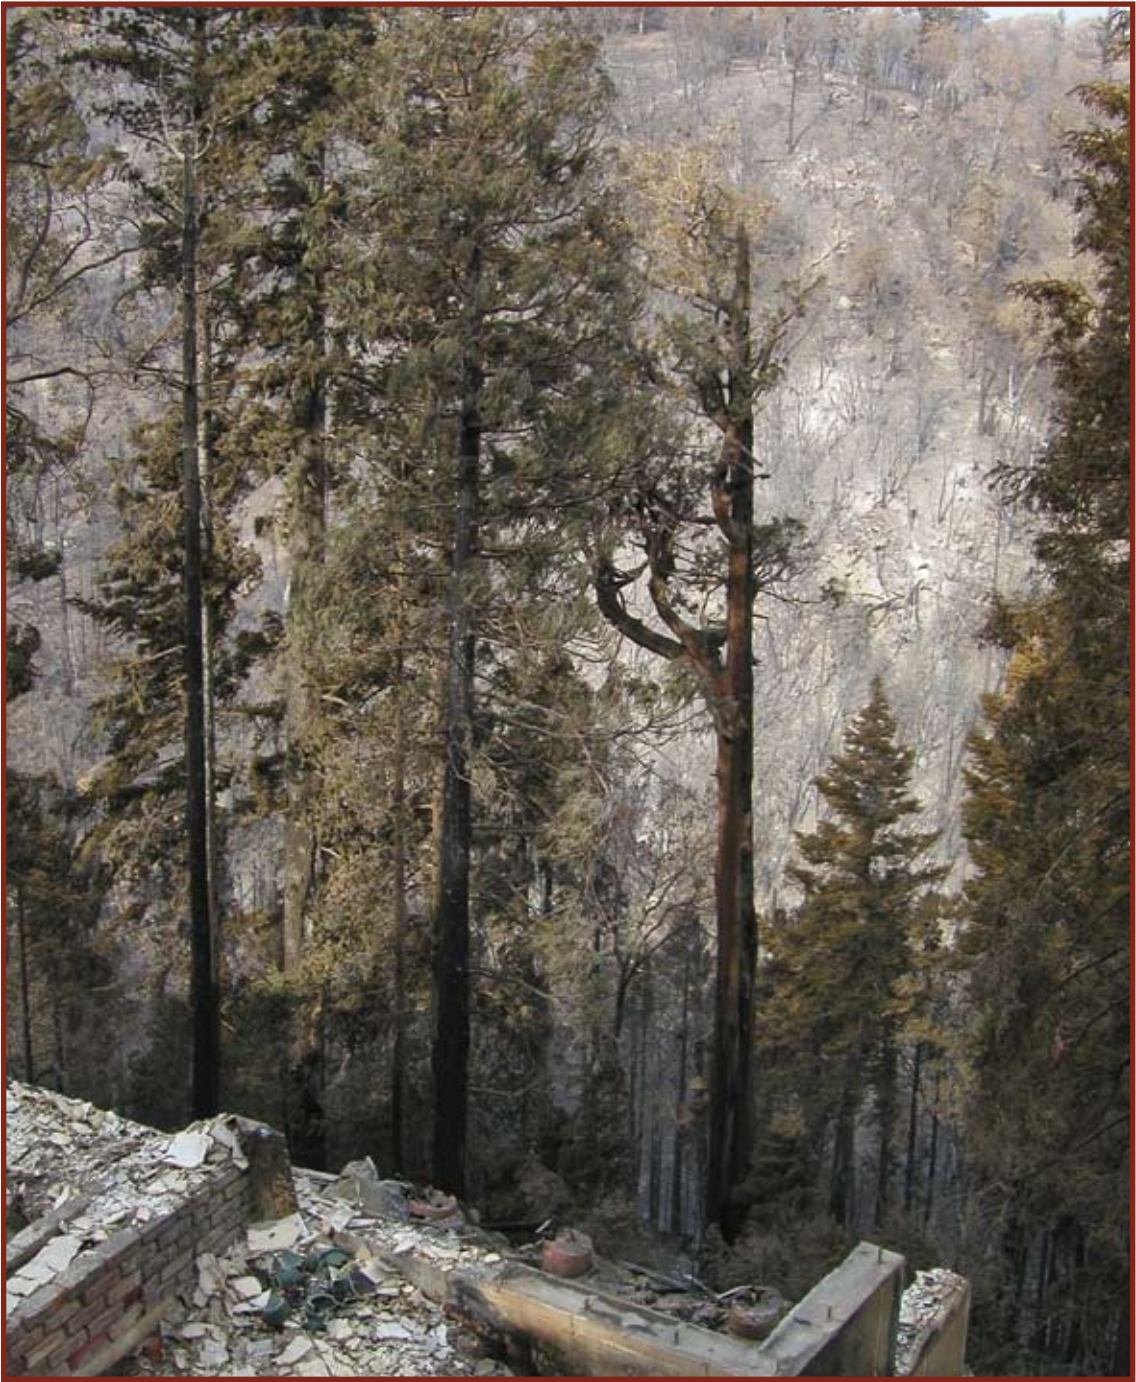
**Figure 13.** Destroyed home at 1114 Brentwood Dr. looking across Grass Valley drainage west. Note the unconsumed canopy indicating this home was destroyed by surface fire and/or directly ignited from firebrands.

The east flank of the Grass Valley Fire progressed upslope into four homes on Brentwood (Figure 13) and southeast into homes on lower Trinity (Figure 14). Fire intensity was low (surface fire) to moderate (shrub and single tree torching).

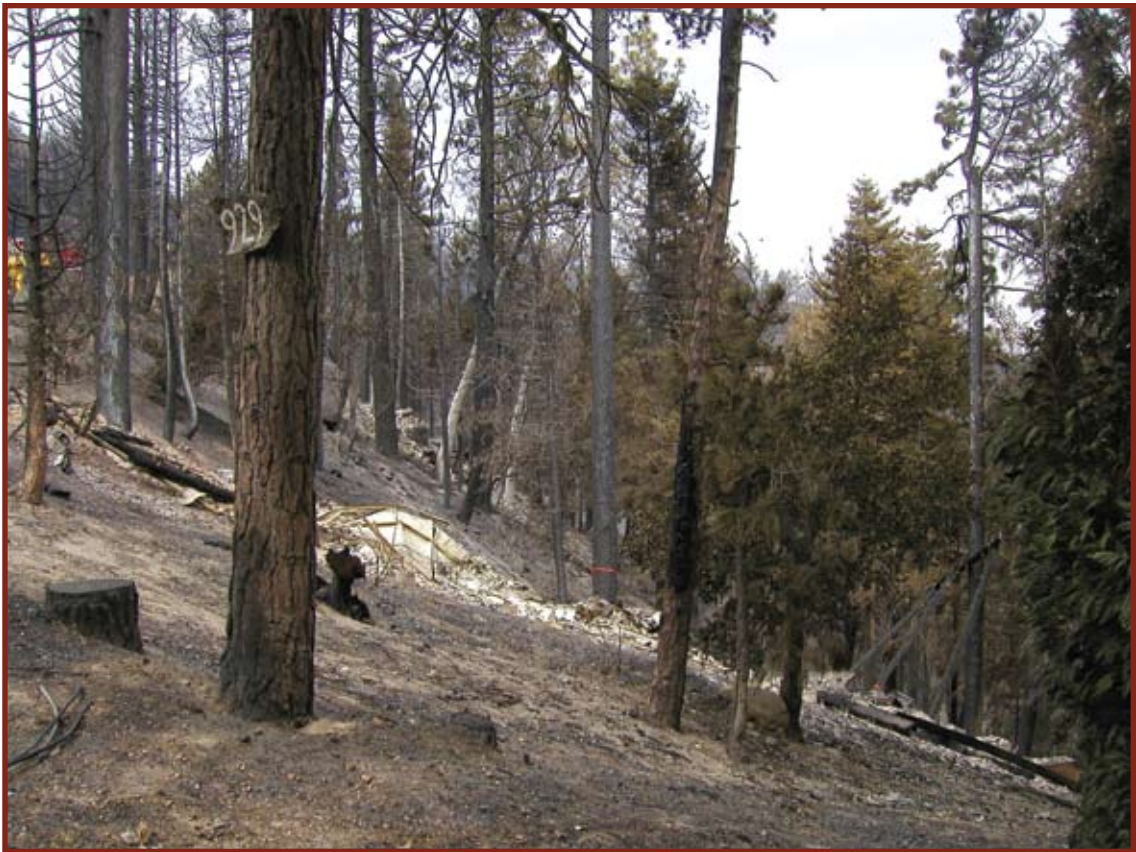
**Figure 14.** Destroyed home at 933 and 941 Trinity Dr. The low hanging, unconsumed canopy suggests that these homes were ignited from a surface fire and/or directly from firebrands.

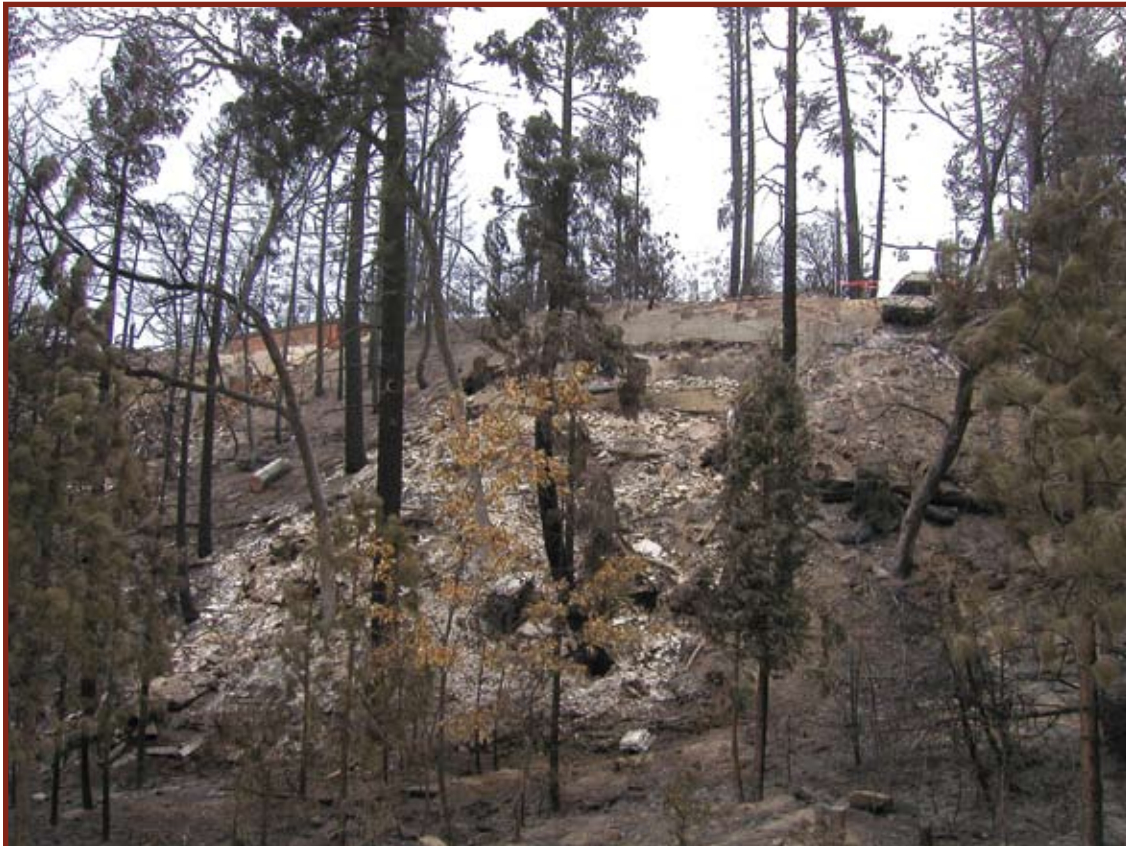
**Figure 16.** Photo of 26787 Merced Ln. from Trinity Dr. Note the steep slope (35-40°) with the remaining debris from the collapsed home spread down the hill.

The steep terrain likely increased fire spread and firebrand production and lofting as well as the downhill cascade of collapsed burning debris (Figure 16). All of these factors result in a 'domino effect' of home destruction (Figures 17 and 18). Although there were significant tactical successes that stopped fire from spreading further along a street, the suppression forces were strategically overwhelmed, due to multiple homes burning simultaneously with little chance of preventing the disaster.

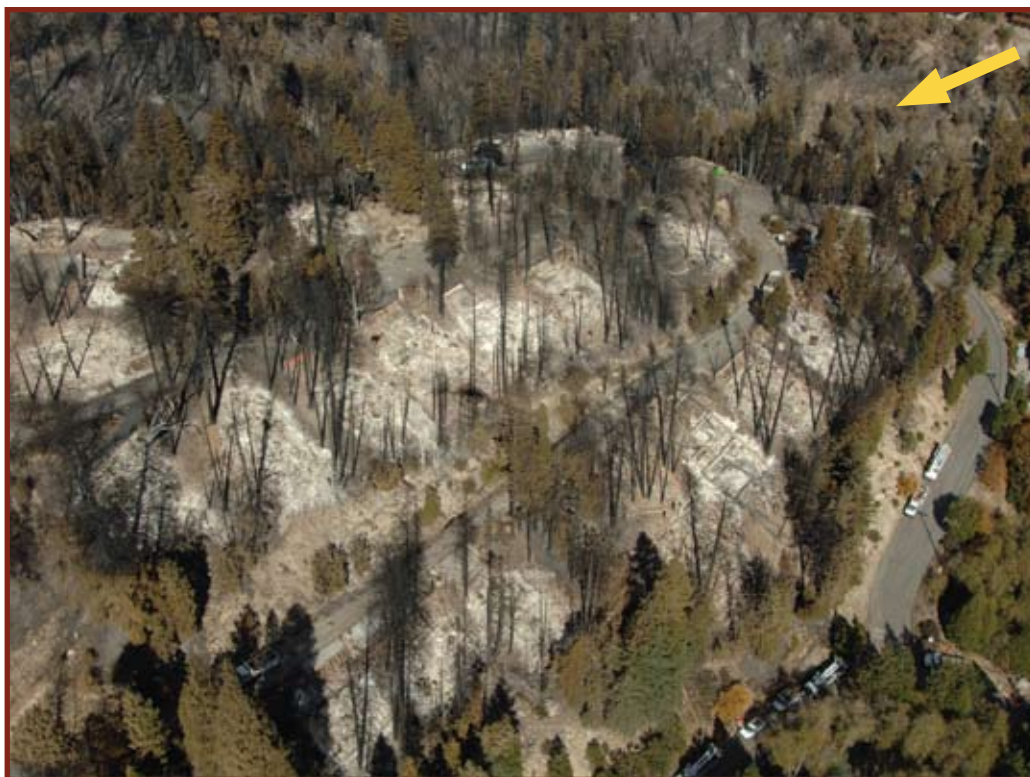
**Figure 17.** An aerial view of home destruction on Modoc Ln. (middle) and Inyo Ct. (top). Trinity Dr. is the road to the right (northeast) that wraps around the hill. Unconsumed tree canopies surround the home destruction. Burned canopies are over and between the destroyed homes. This indicates that the trees burned due to the burning homes, and the head fire that impacted Trinity Dr. from the north (arrow) did not continue into the subdivision. In this area, home destruction is primarily house-to-house. (Photo by Tom Iraci)

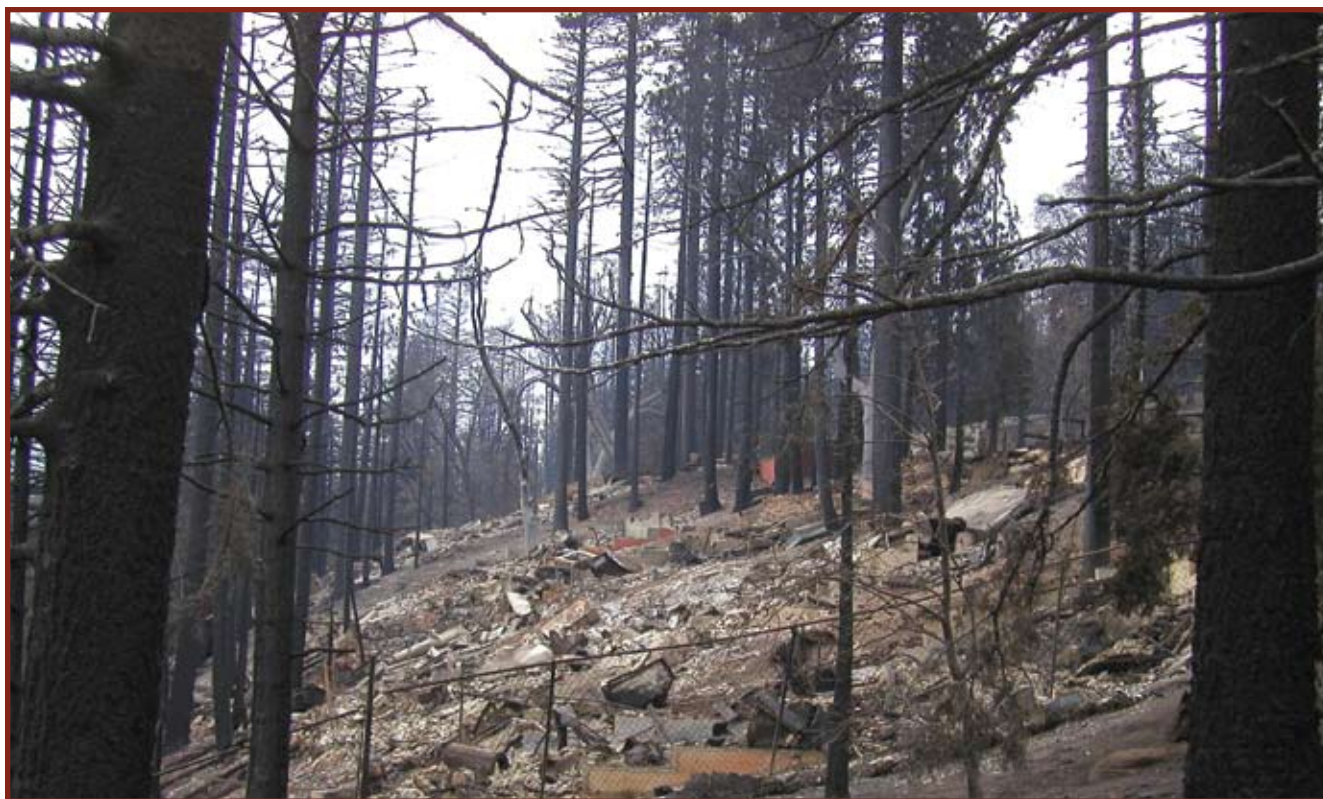
**Figure 18.** View of seven destroyed homes looking southwest on Inyo Ct. The burning homes primarily caused the tree canopy consumption.

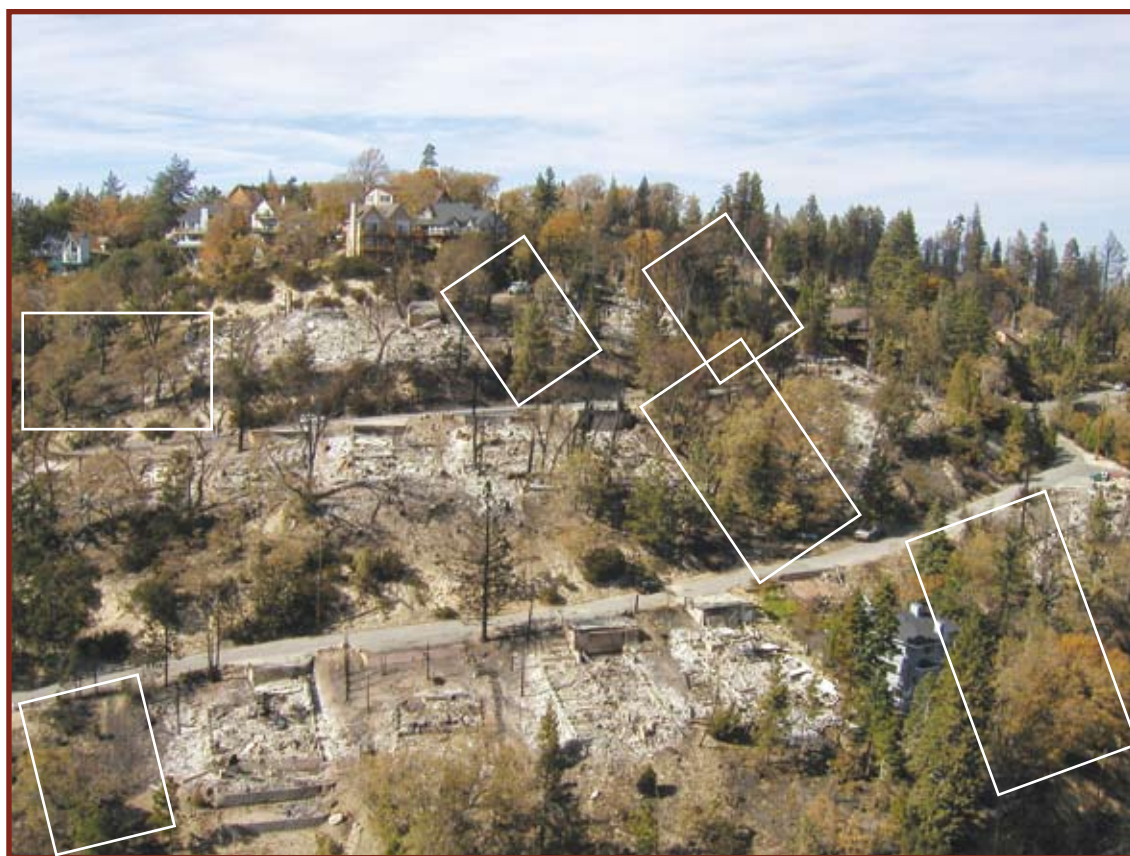
**Figure 20.** Aerial view facing west with Madera Ln. at the bottom, Del Norte Ln. in the middle, and Sonoma Dr. just below the homes at the top of the hill (Kings Ct.). Note the unconsumed vegetation between the destroyed homes, particularly in the vacant parcels that were burned by surface fire (framed areas).

Fires followed the hillside around to the southwest (Figure 19). Homes near the top of the hill (on Sonoma, Del Norte, and Madera) (Figures 20-22) and mid-slope (Marin) (Figure 23) were exposed first. Firebrands, possibly from 837 or 845 Del Norte, likely spotted across Madera and ignited a

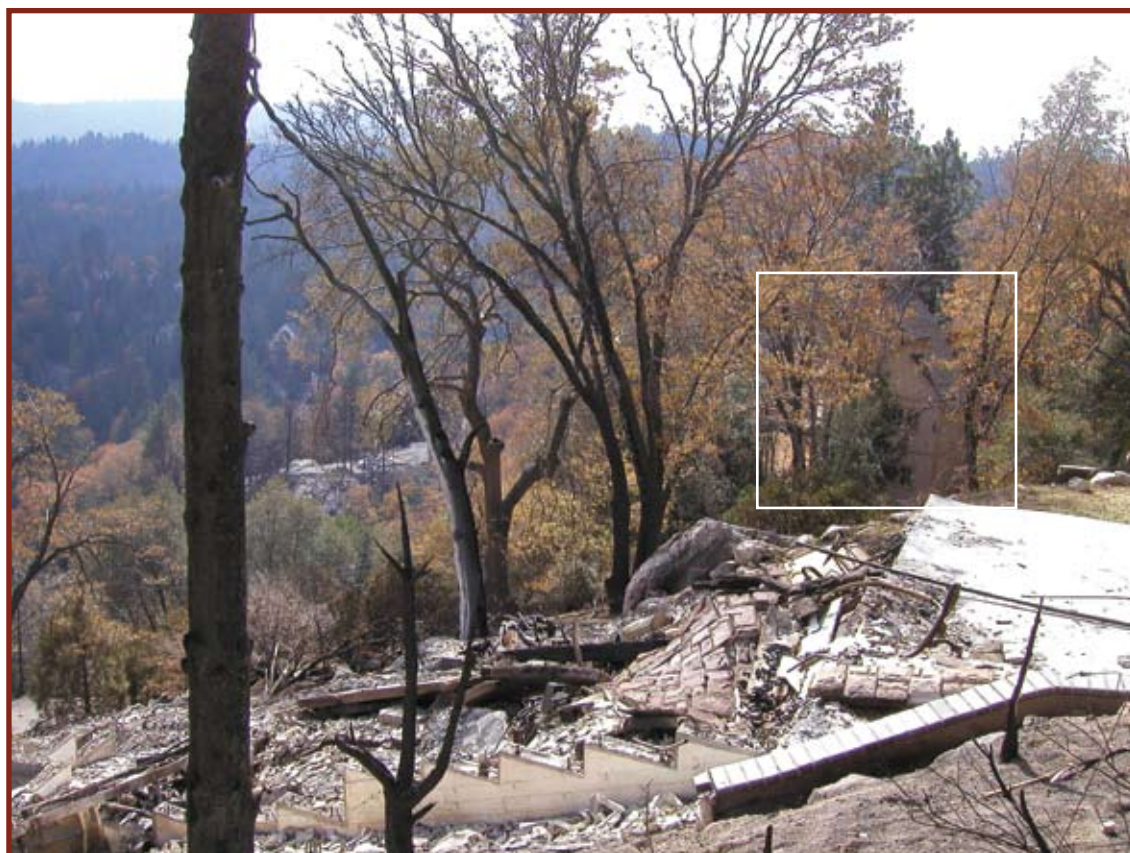
**Figure 21.** Destroyed homes at 899 and 905 Sonoma Dr. looking southwest through two vacant parcels that surface burned with an undamaged home (framed) in the background (875 Sonoma).

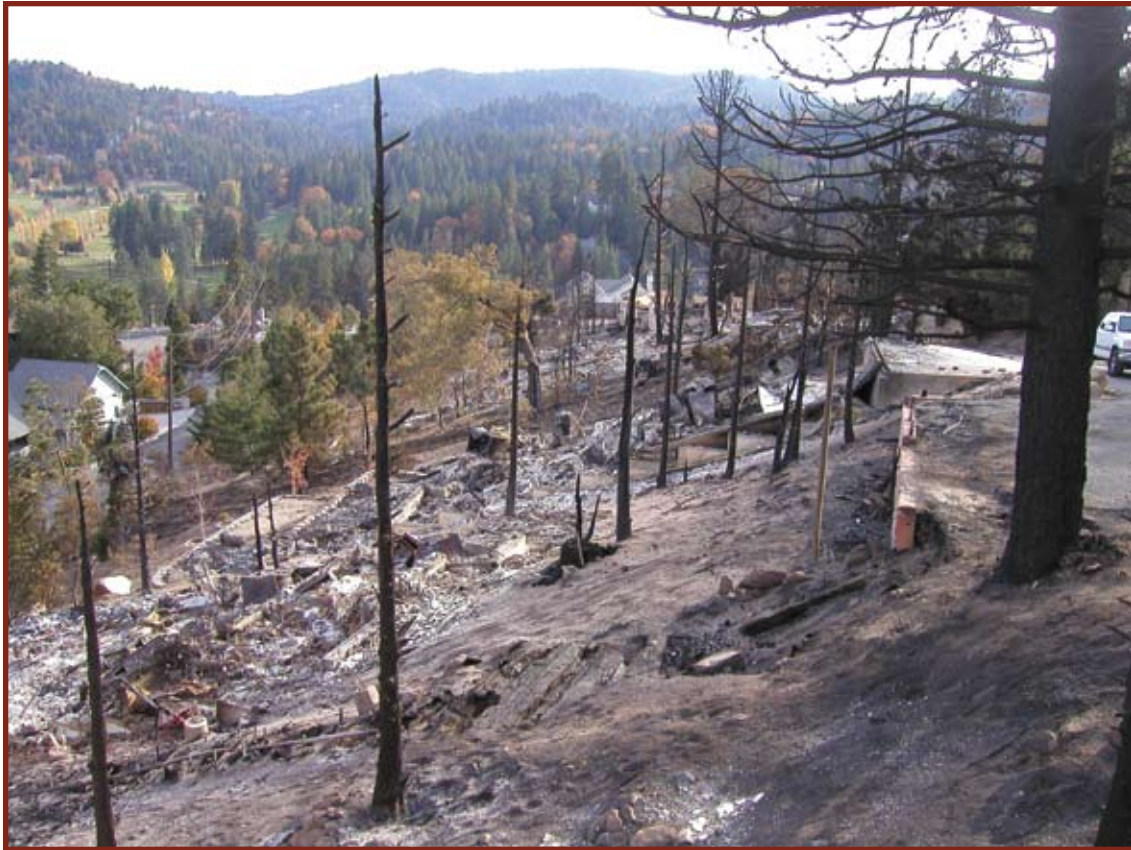
**Figure 22.** View of five destroyed homes on Madera Ln. looking south to Lake Arrowhead Country Club. The unconsumed tree canopies, in the middle-left of the photo, are in a vacant lot that surface burned.

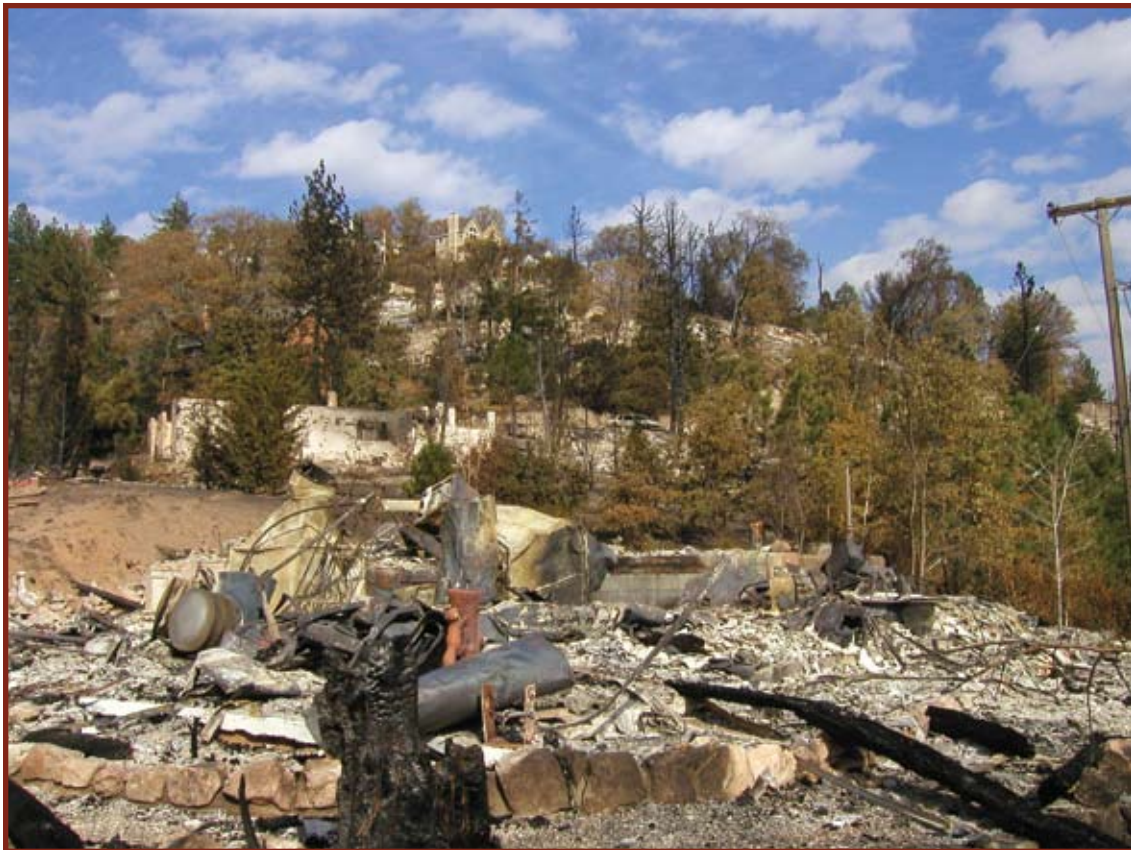
**Figure 23.** A view to the northwest upslope from 810 Marin Ln. through four levels of home destruction. The unconsumed vegetation between rows of destroyed homes indicates that a high intensity vegetation fire did not spread through the residential area.

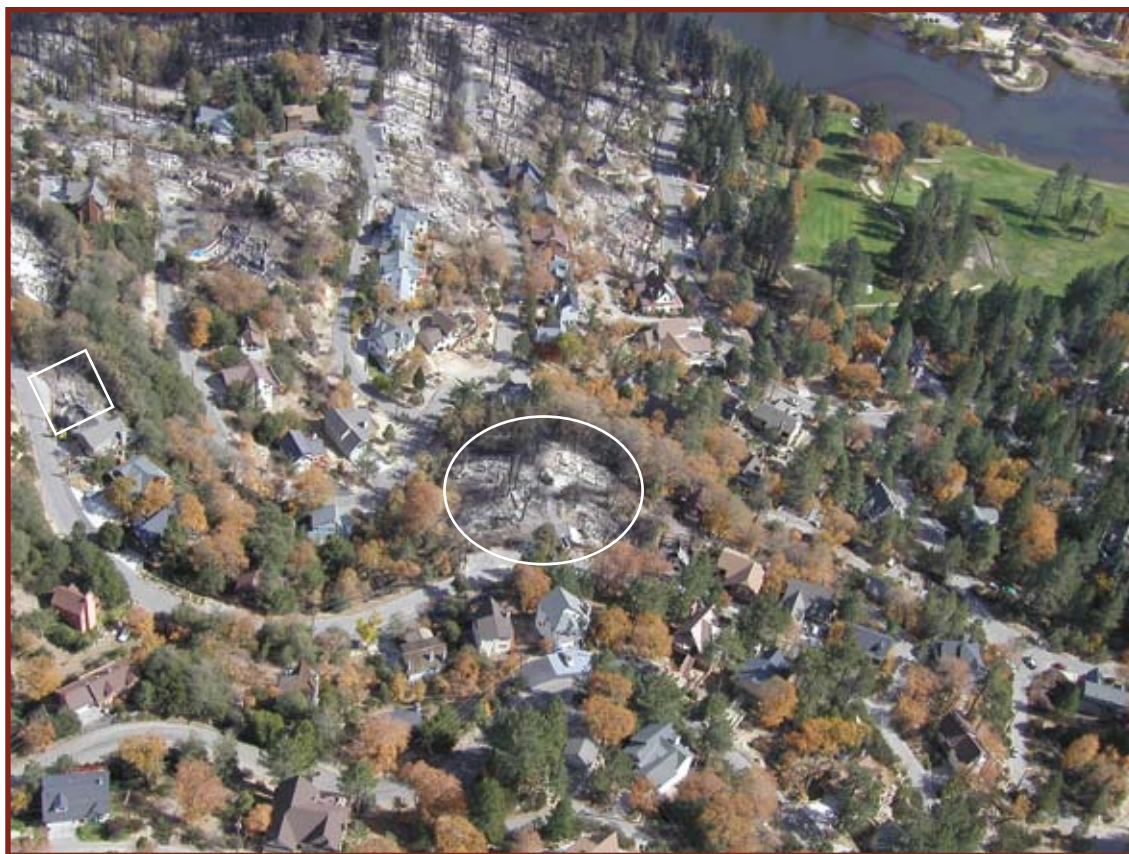
**Figure 24.** Aerial view looking down on five homes (circled) on Del Norte Ln. and Merced Ln. that were initially started by firebrands, possibly from burning homes or vegetation at 837 or 845 Del Norte (framed).

home(s) on Madera/Del Norte resulting in the eventual loss of five homes (Figure 24). At approximately 1100, the wind shifted north-northwesterly, spreading fire and burning debris downhill (southeast) to Merced, Modoc, and Brentwood (Figures 25-27).

Madera (see Figure 24), start a surface fire and/or directly ignited 26530 Placer resulting in destruction (Figures 29 and 30). The burning house caused minor exterior damage to the neighboring house at 26540.

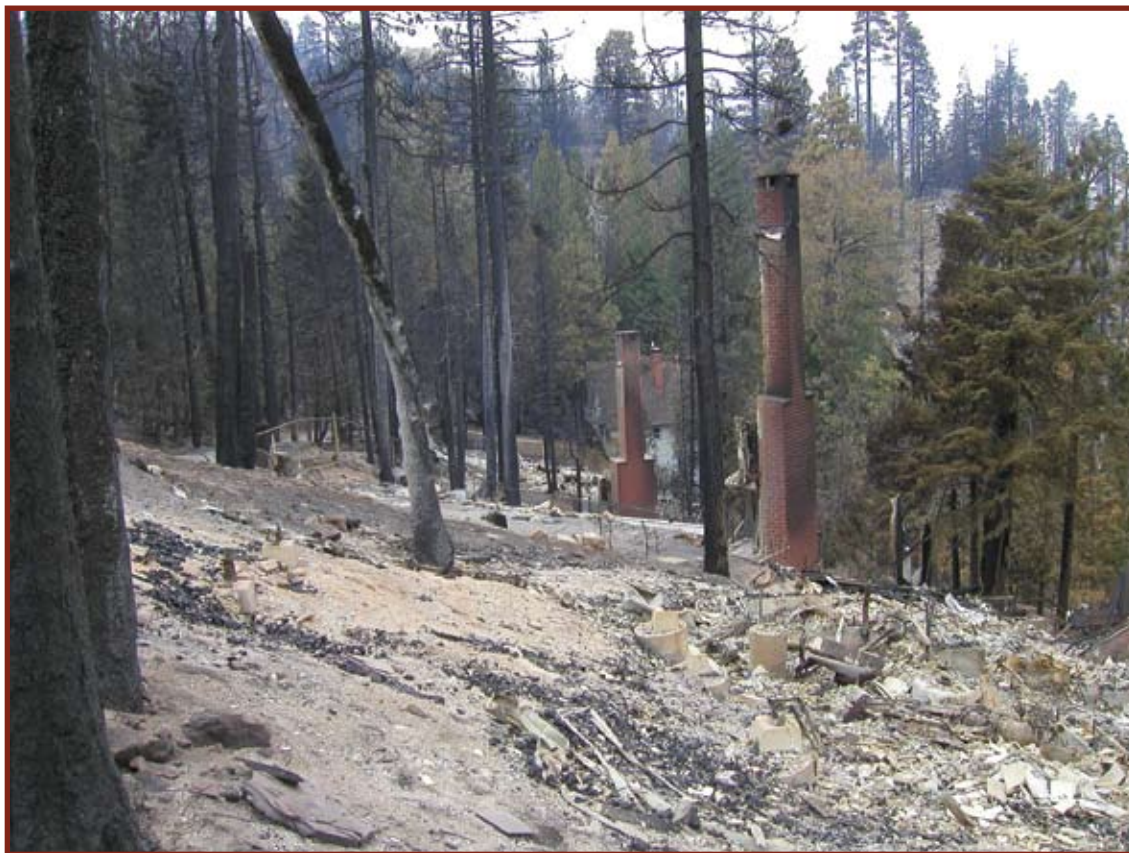
**Figure 25.** Four destroyed homes on Brentwood Dr. looking northwest. The home in the background is 850 Brentwood.

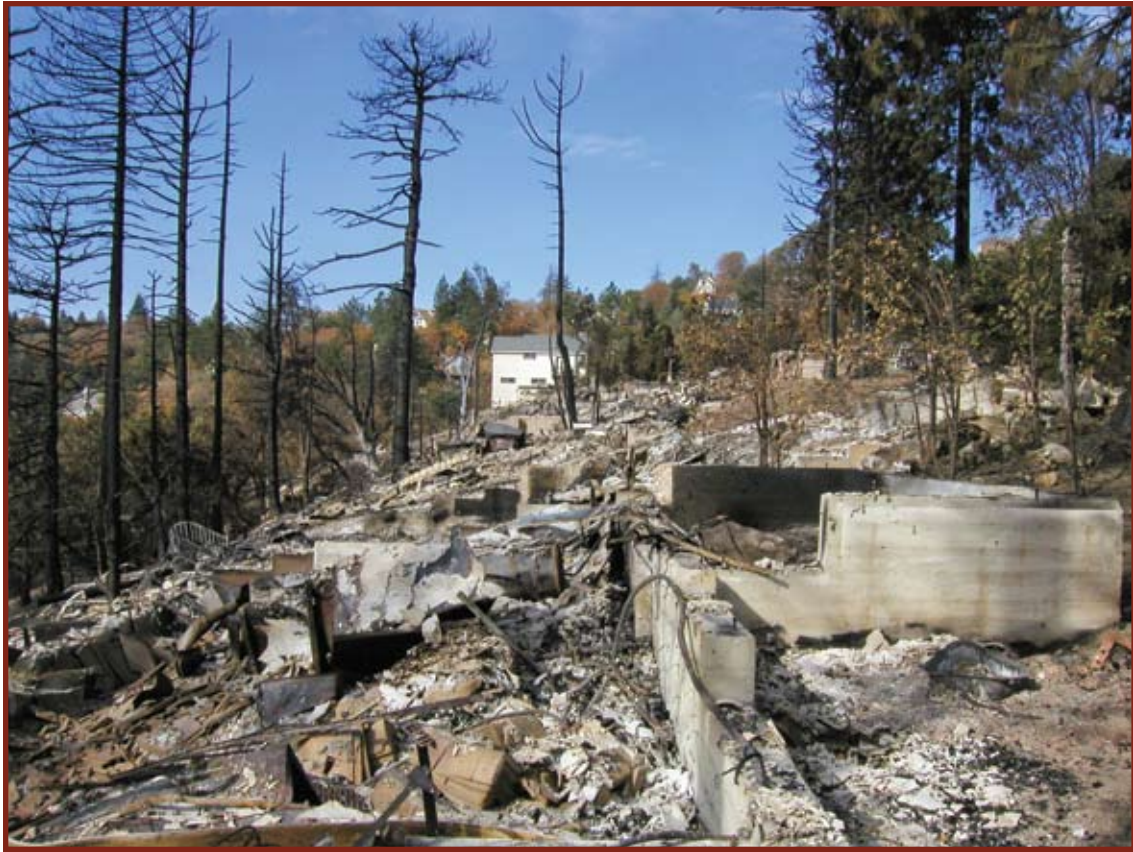
**Figure 26.** View looking west through seven destroyed homes on Merced Ln. to the white house at 26665.

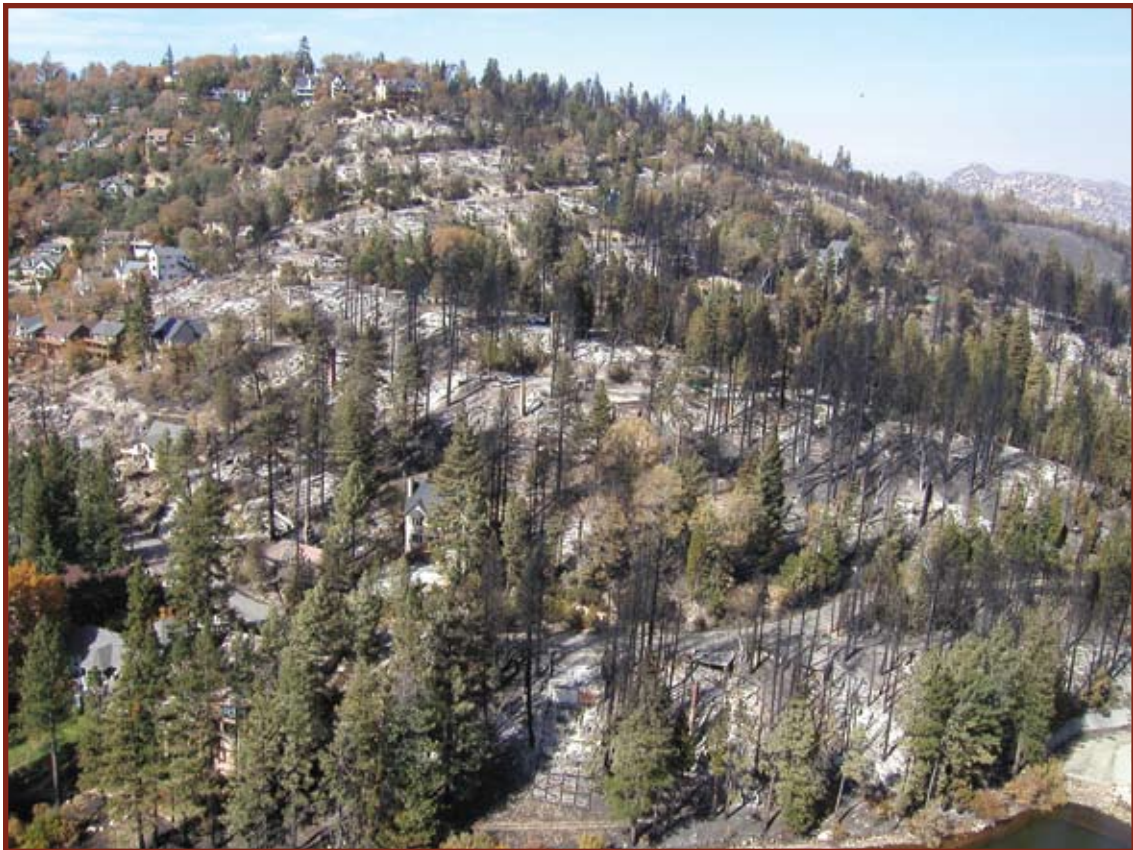
**Figure 27.** Aerial view to the northwest of homes on Brentwood Dr. (bottom) and Modoc Ln. (center). Areas with blackened trees are a result of the homes burning the vegetation. At about 1100, the wind shifted north-northwesterly, spreading fire and firebrands downhill to the southeast.
