R5-TP-026b

# Home Destruction Examination

## Grass Valley Fire

Lake Arrowhead, CA

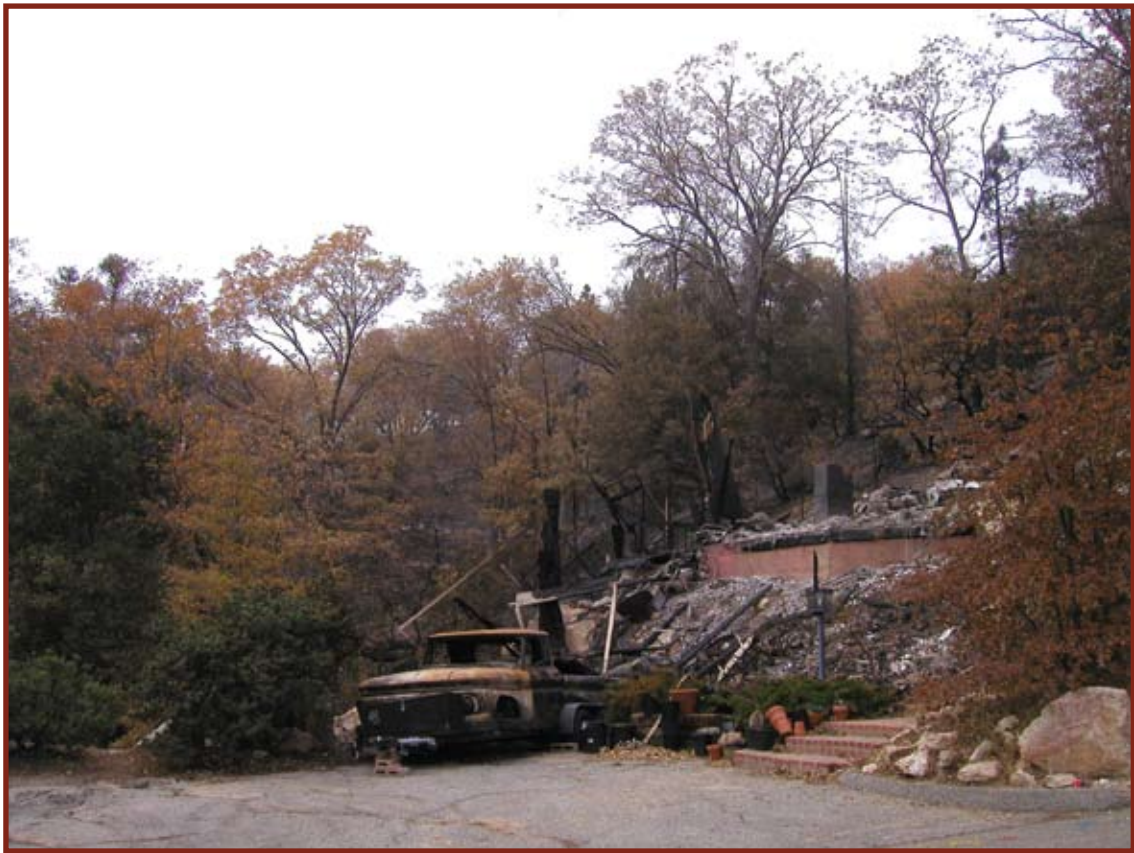
**Figure 28.** View of 710 Sonoma Dr. National Forest System lands are directly behind the destroyed home (west). The unconsumed vegetation surrounding the destroyed home indicates the likely cause was surface fire and/or firebrand(s). The neighboring house directly uphill survived (out of view to the right at 26516 Amador Ln.).

A spot fire west of 700 Sonoma and east of Tunnel 2 Rd. grew to about 35 acres. A surface fire and/or firebrand(s) directly ignited 710 Sonoma (Figure 28). Firebrands, possibly from the five burned homes on Del Norte/

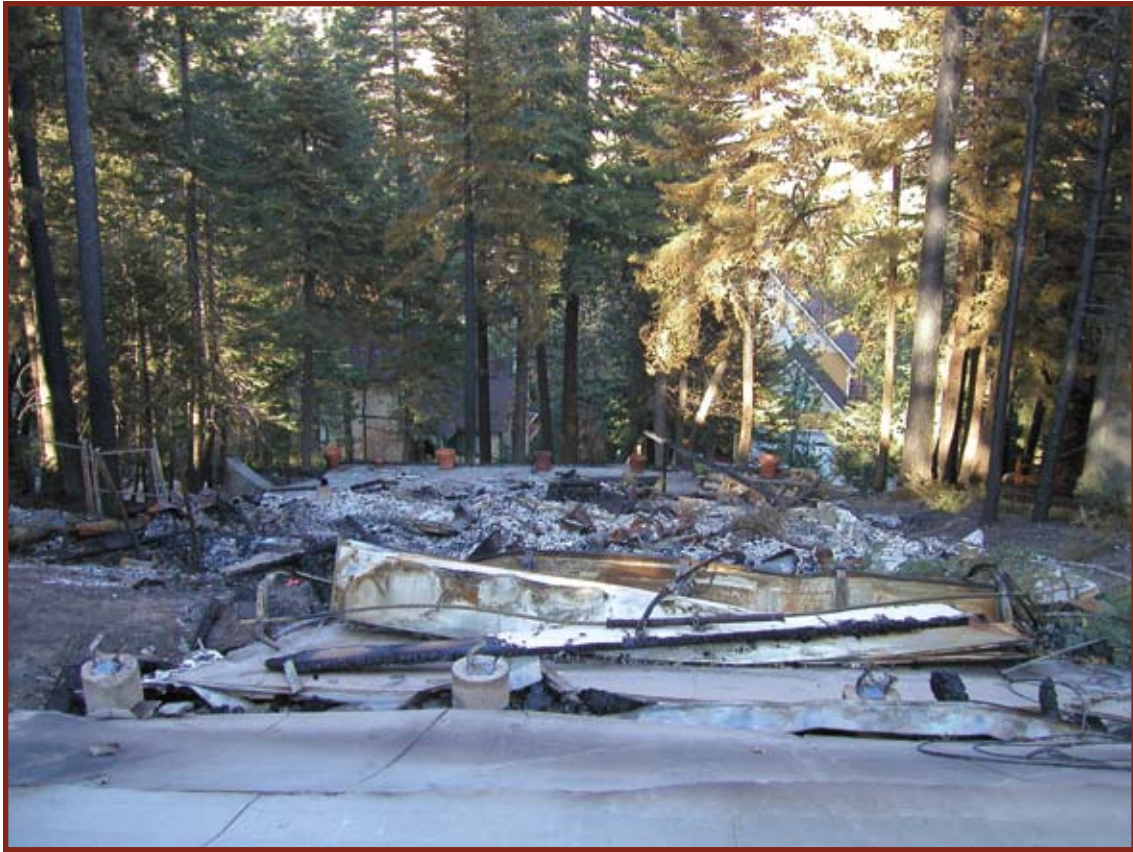
**Figure 29.**  
View of 26530  
Placer Ln. This  
home ignited  
from surface  
fire and/or  
firebrands.

Madera (see Figure 24), start a surface fire and/or directly ignited 26530 Placer resulting in destruction (Figures 29 and 30). The burning house caused minor exterior damage to the neighboring house at 26540.

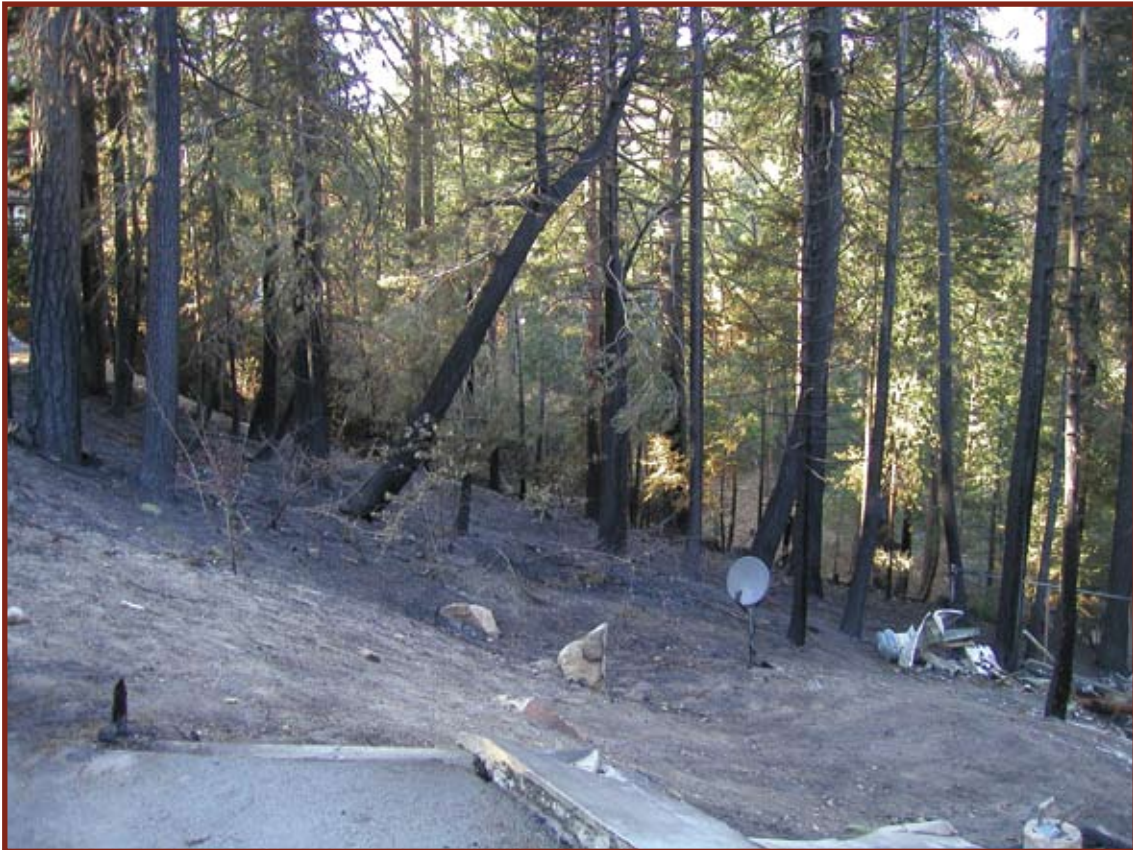
**Figure 30.**  
View from  
26530 Placer  
Ln. (destroyed)  
to the north-  
west through  
three vacant  
parcels that  
burned with  
low intensity  
surface fire.

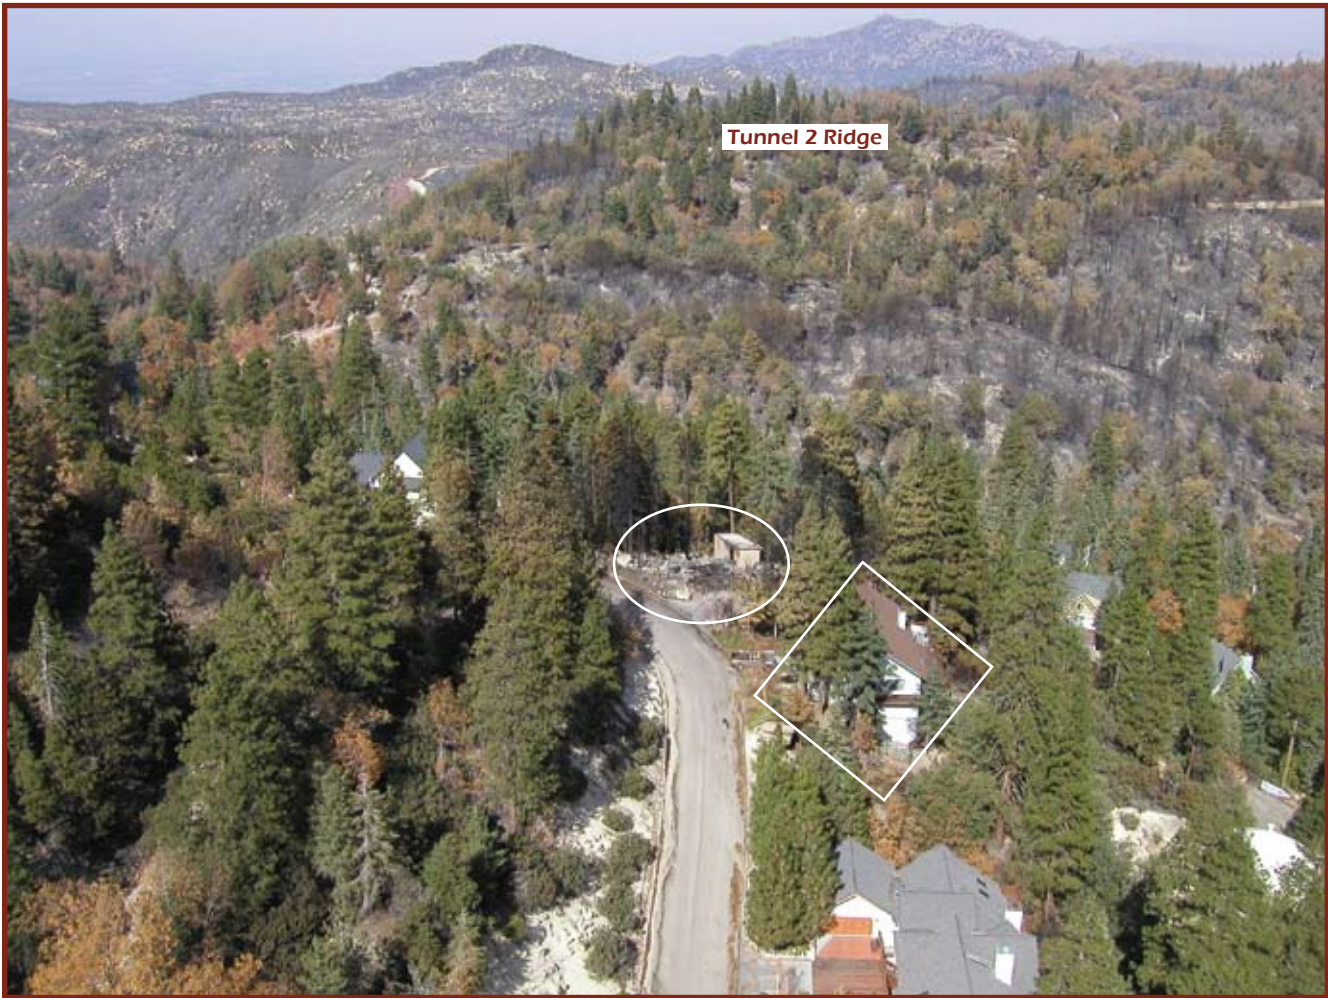
**Figure 31.** Aerial view looking northwest up Walnut Hills Dr. to destroyed home at 26142 (circled) and damaged home at 26150 (framed). Tunnel 2 Ridge is directly across drainage and shows evidence of group tree torching.

Firebrands, possibly from an area of torching across the drainage from Walnut Hills Dr. (Tunnel 2 Ridge) (Figure 31), started several spot fires upslope of Fairway Dr. Surface fire and/or firebrand(s) destroyed 26088 (Figure 33); 26142 (Figure 32). Surface fire and/or firebrand(s) destroyed 26088 (Figure 33); 26150 Walnut Hills (Figure 31) it was severely damaged on the sides exposed to 26142 (Figure 32). Surface fire and/or firebrand(s) destroyed 26088 (Figure 33); 26305 received minor exterior damage.

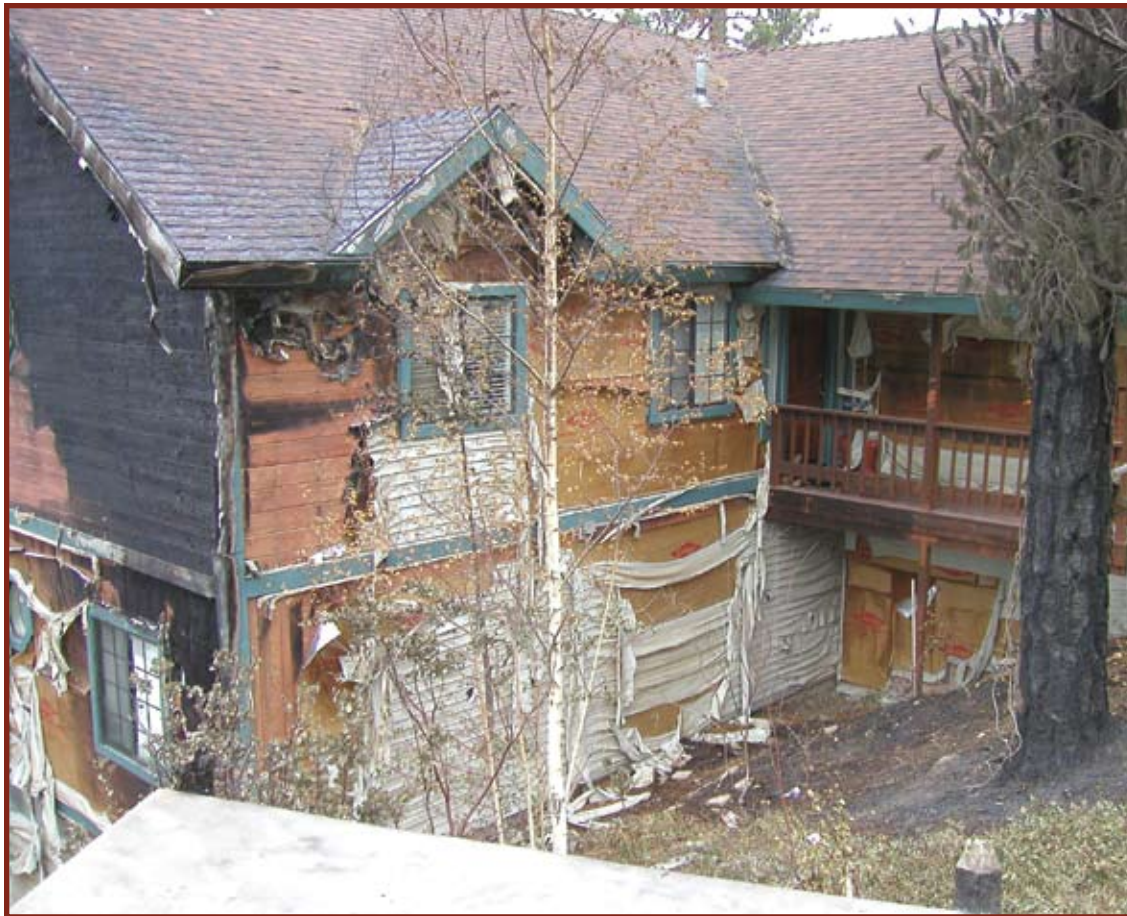
**Figure 32.** Home at 26150 Walnut Hills Dr. Thermal exposure from the destroyed home at 26142 contributed to the vinyl sloughing off. Surface fire burned the vinyl siding and under-layment on the northwest side (left) and worked its way up the wall burning the wood siding. Blackened asphalt shingles in the roof valley (center top) are from accumulated needles that burned.

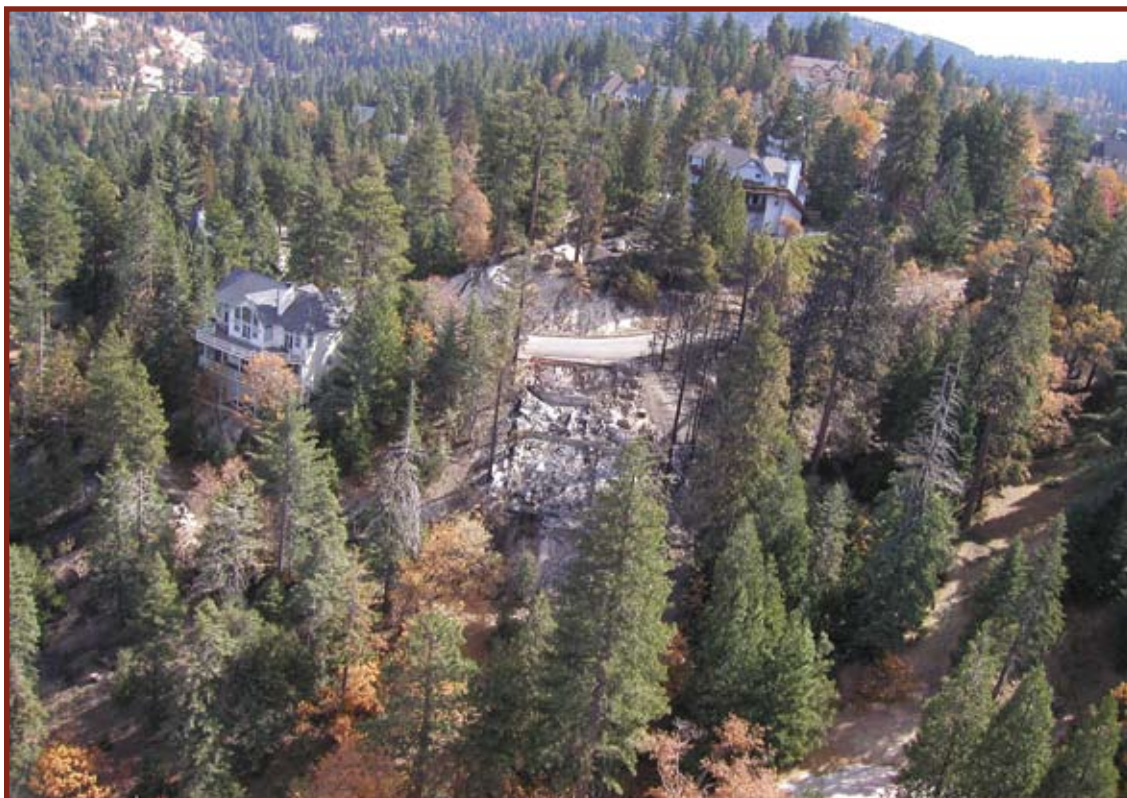
**Figure 33.** Aerial view looking southeast at 26088 Walnut Hills Dr. This destroyed home was ignited by a surface fire and/or firebrand(s). Note the steep slope, cascading debris field at the destroyed home site, and the unconsumed vegetation surrounding the destruction.
