Inspection Report

Spot on Pinellas Home Inspections

3201 29th Terrace North St. petersburg FL 33710

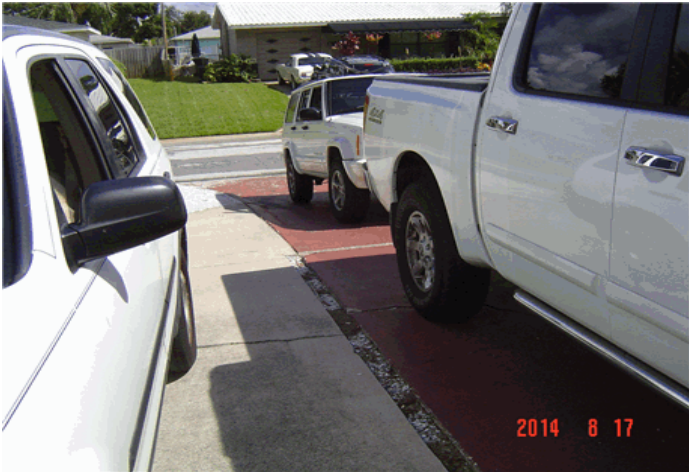
1) Grading Conditions

Grading of the soil near the foundation appears to be in serviceable condition.

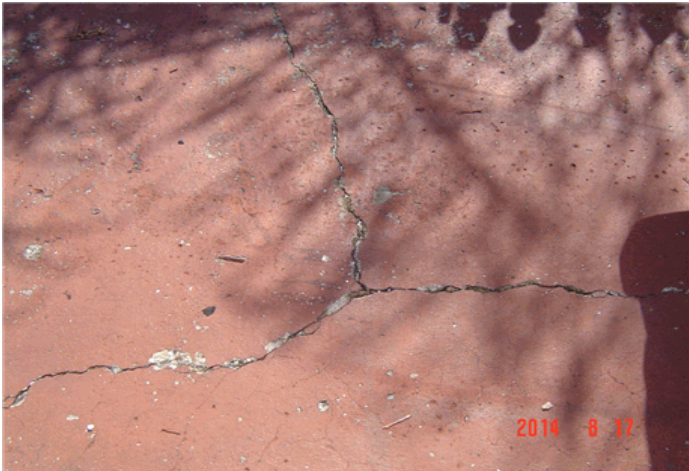
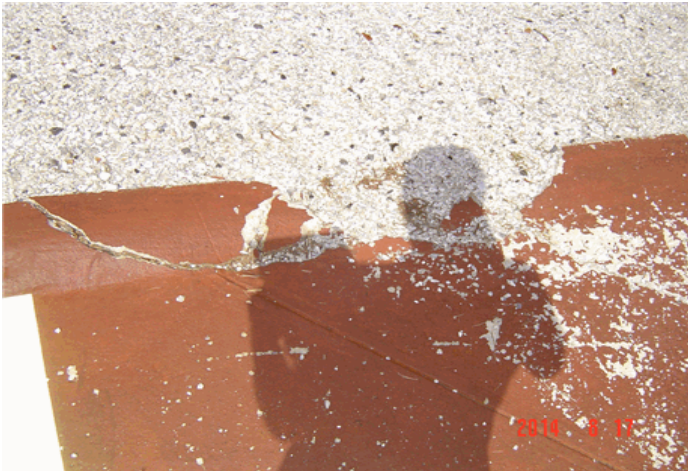
2) Driveway Conditions

Common cracks were observed in the driveway.

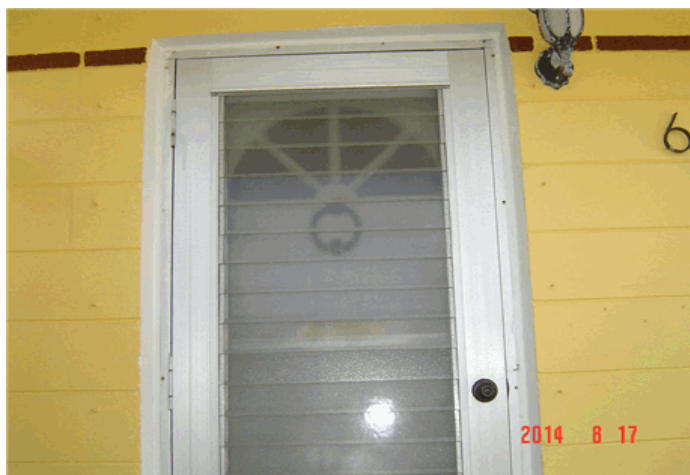
4) Front Entrance Conditions

The visible and accessible areas of the porch appeared to be in serviceable condition at the time of the inspection.

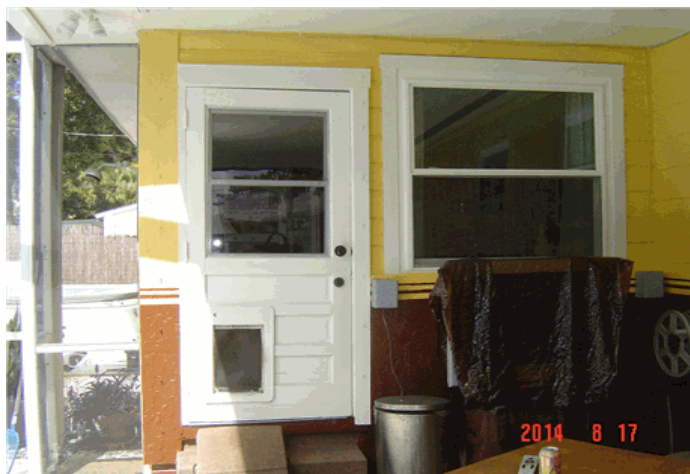
5) Back Entrance Conditions

The visible and accessible areas of the deck appeared to be in serviceable condition at the time of the inspection.

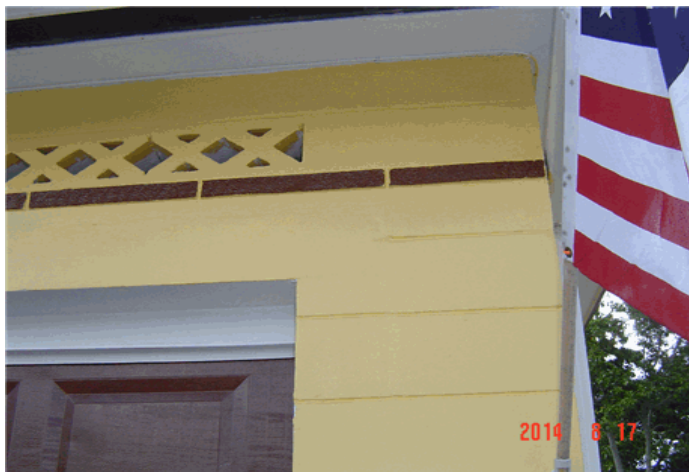
The visible and accessible portions of the exterior wall coverings appeared to be in serviceable condition at the time of the inspection.

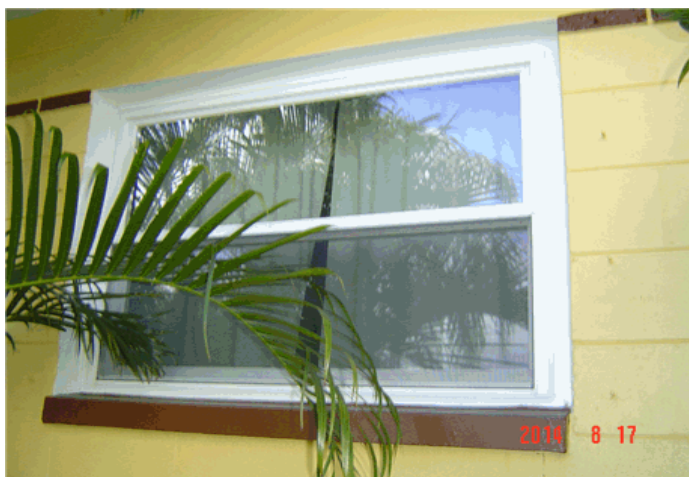
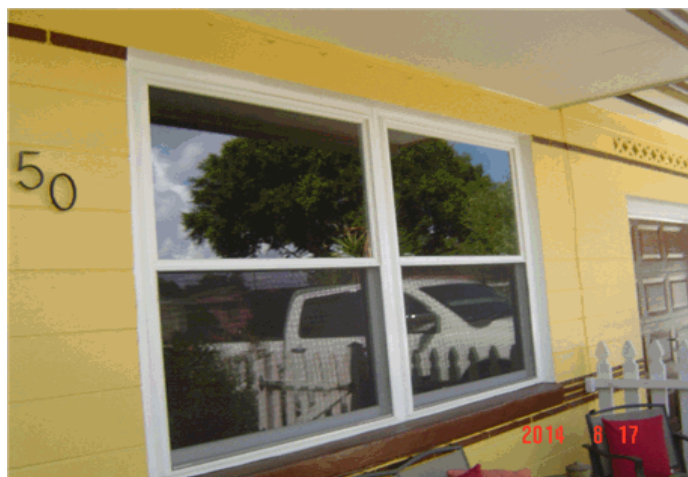
7) Window Conditions**AS**

Double Pane New

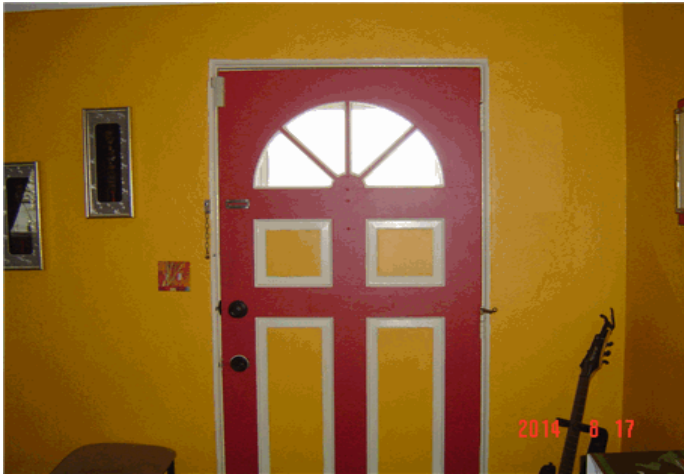
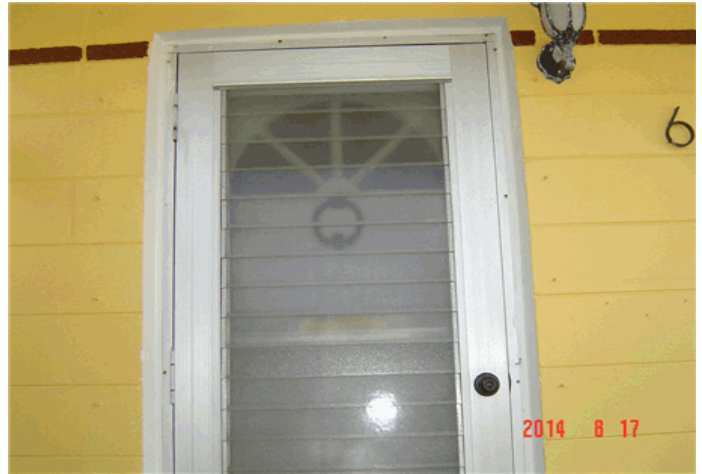
**8) Exterior Door Conditions****AS**

The door(s) appeared to be in serviceable condition at the time of the inspection.

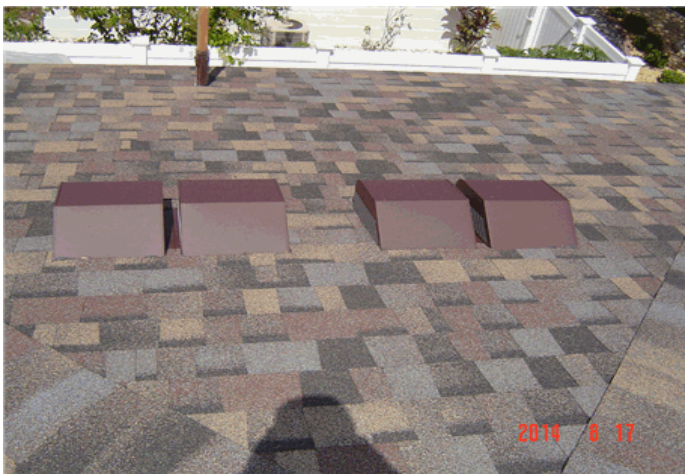
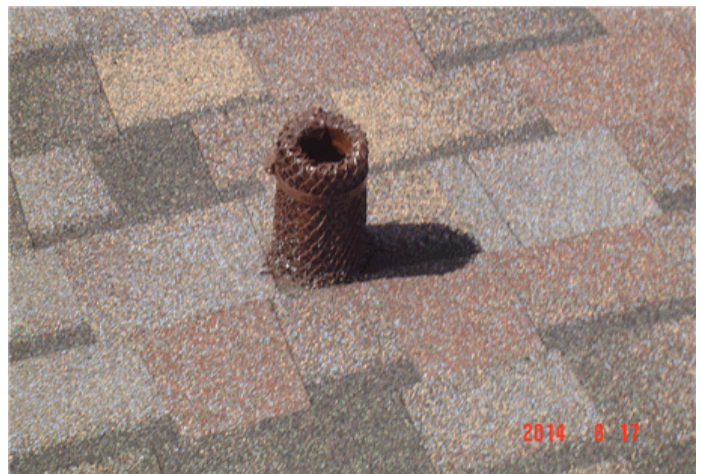
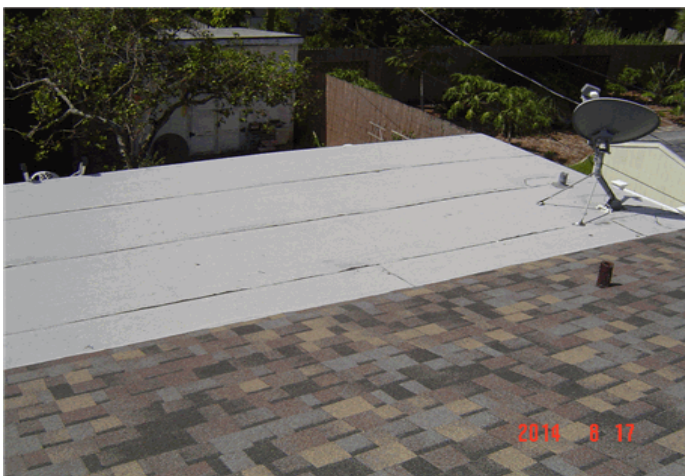
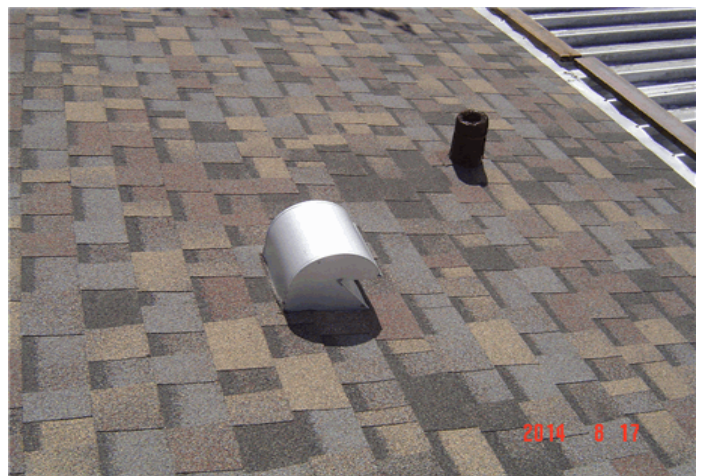
10) Roof Covering Condition

Replaced 2013

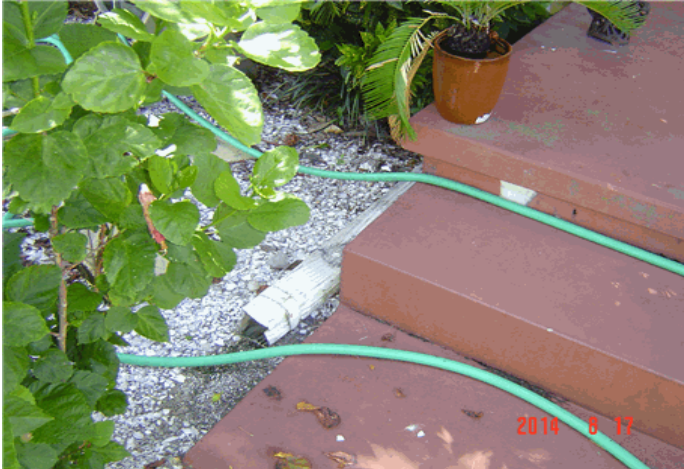
The gutter system appeared to be in serviceable condition at the time of the inspection.

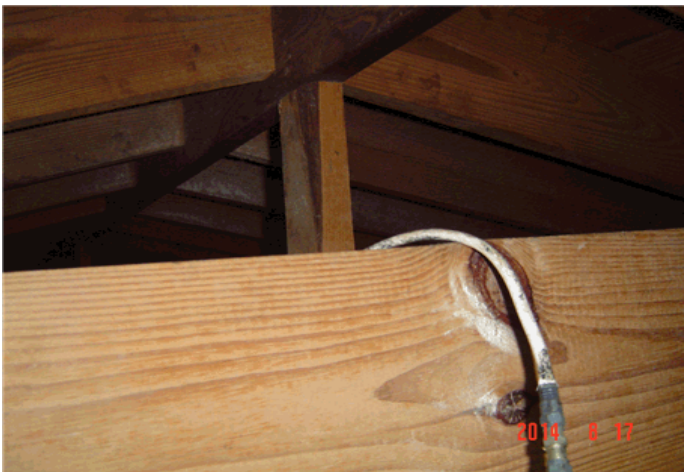
The visible and accessible portions of the attic appeared to be in serviceable condition at the time of the inspection.

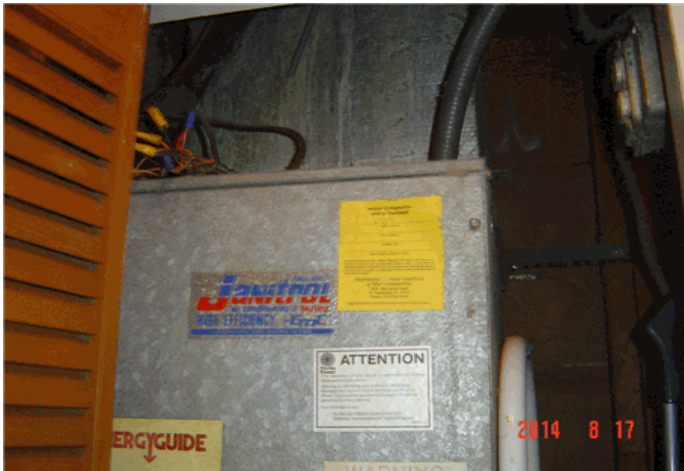
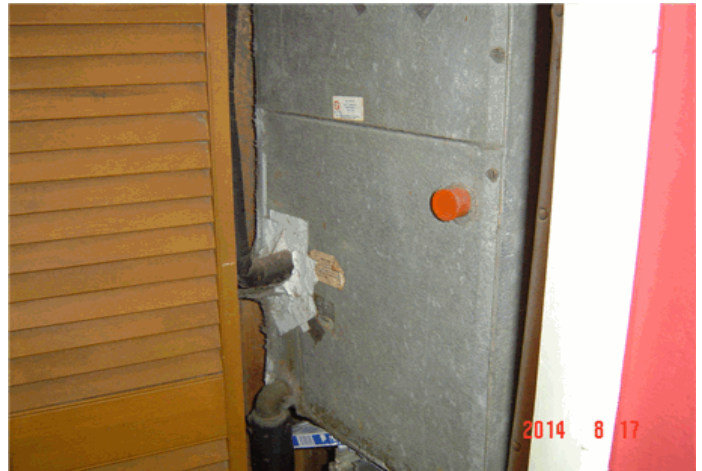
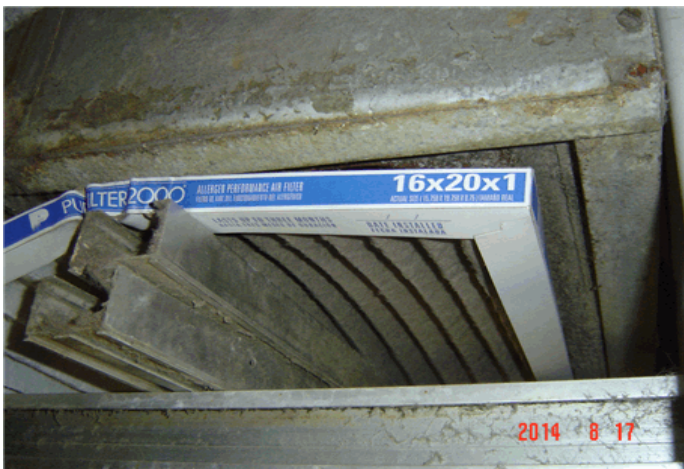
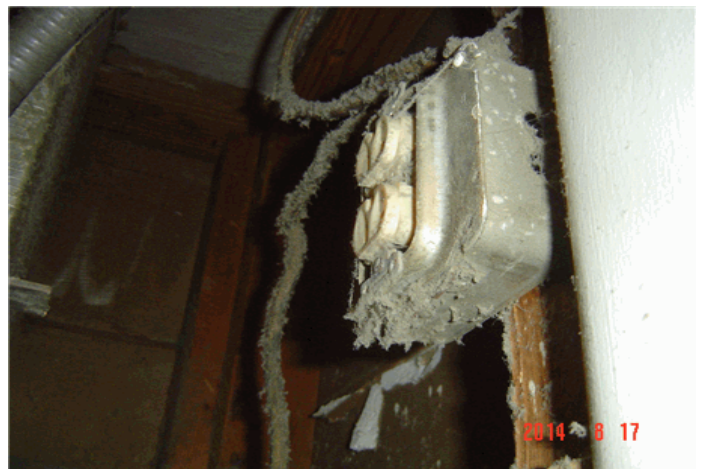
15) Unit Conditions

Evidence of deferred maintenance was observed.
Recommend cleaning and / or general servicing of the heating unit by a licensed / qualified heating contractor prior to close.

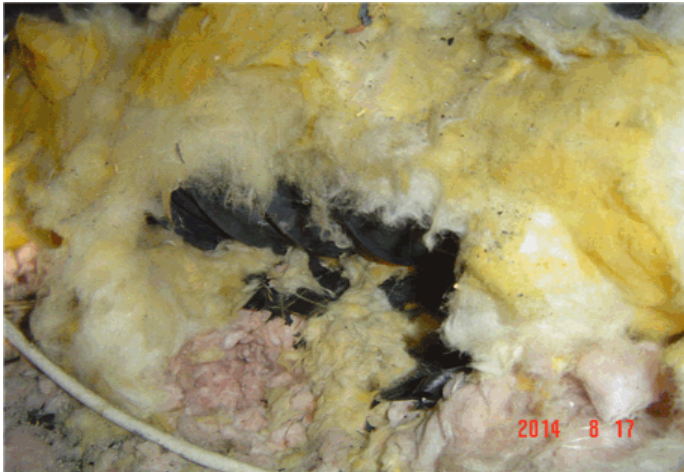
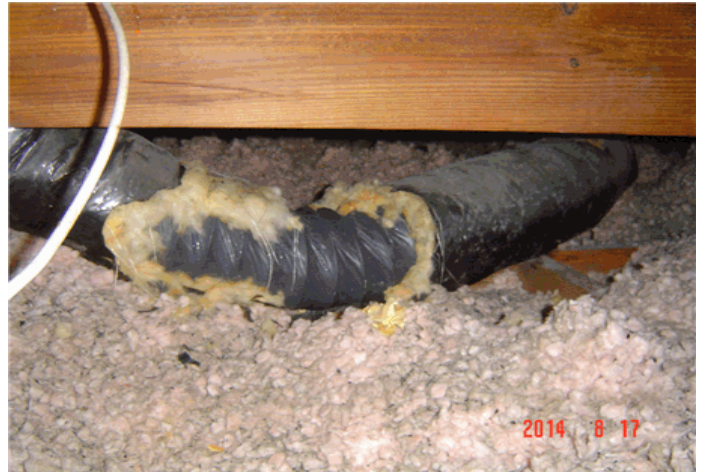
16) Distribution Conditions**R**

Rodent damage

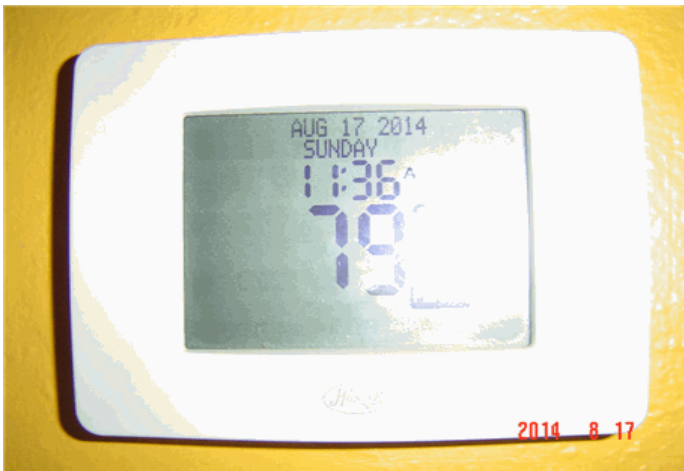
**17) Thermostat Condition****AS**

The normal operating controls appeared to be serviceable at the time of the inspection.

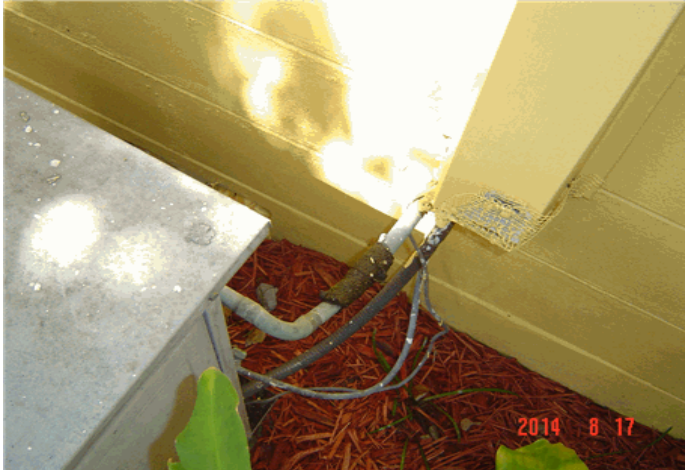
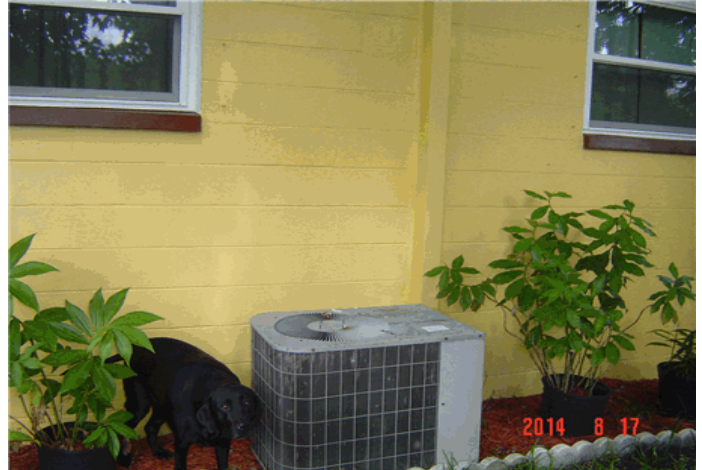
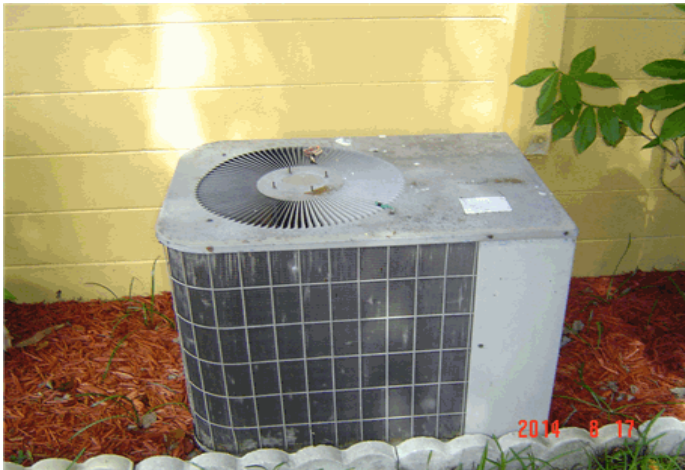
No exterior electrical disconnect was provided at the exterior condensing unit. Today's construction requires a means for disconnect at the unit. The insulation on the refrigerant lines was missing or deteriorated. Recommend installing this rather

inexpensive pipe insulation to improve efficiency. Pipe insulation is available at most hardware stores. The unit appears to be past its life expectancy. Client should consider replacement with a modern unit conforming to higher efficiency standards.

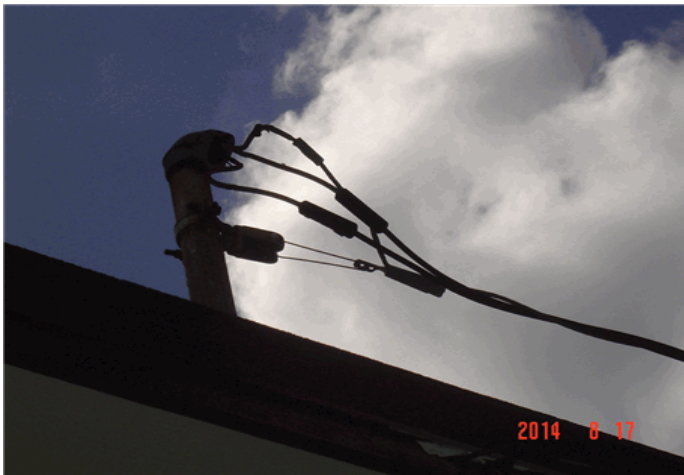
19) Electrical Service Conditions

The main service entry appeared to be in serviceable condition at the time of inspection.

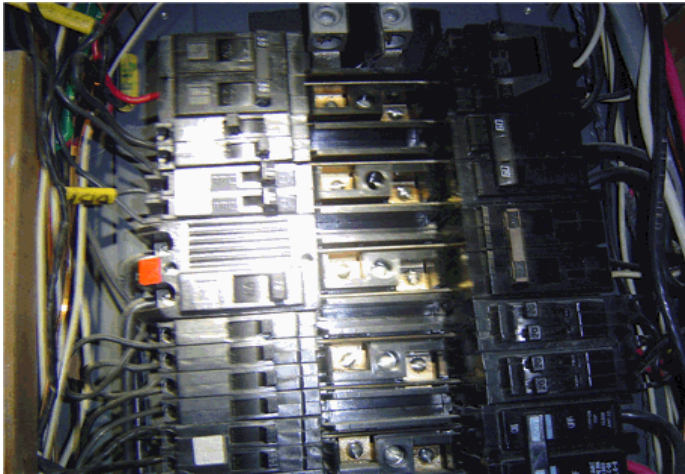
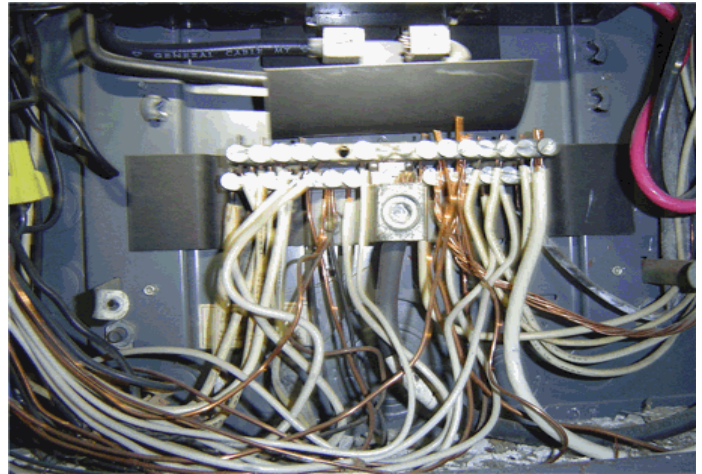
20) Wiring Methods

The main power cable is copper. The branch cables are copper.

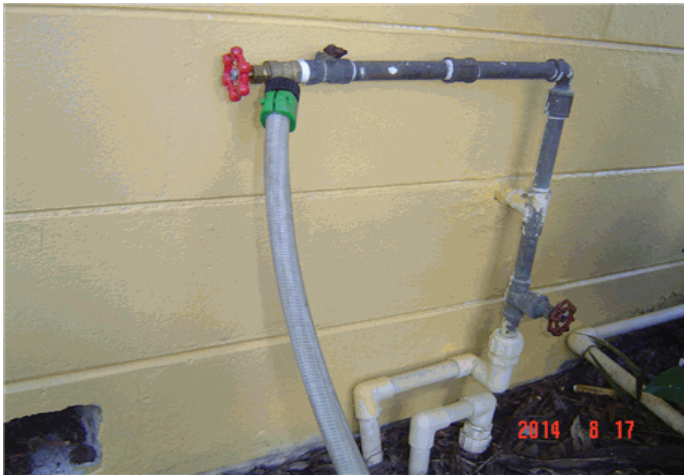
22) Main Line & Valve Conditions**AS**

The visible portion of the main pipe and valve appeared to be in serviceable condition at the time of the inspection.

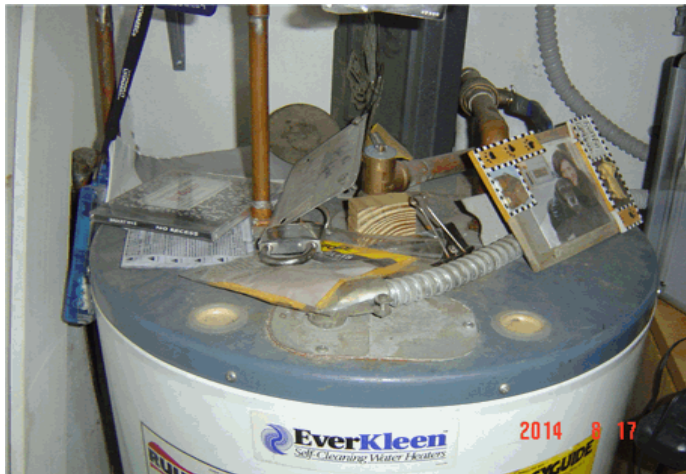
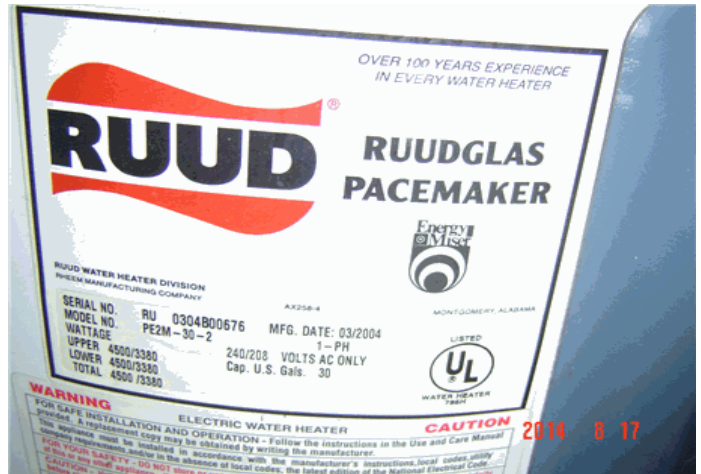
25) Water Heater Conditions

The water heater was operable at the time of inspection. This does not however guarantee future performance, operation, or condition. 2004

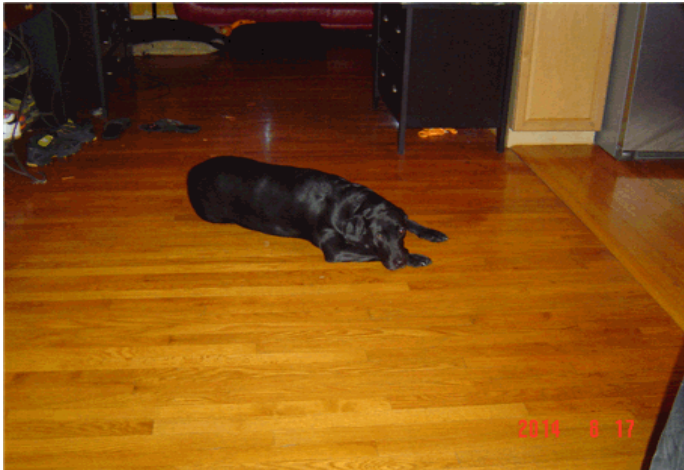
The general condition of the visible and accessible portions of the floors appeared to be in serviceable condition at the time of the inspection.

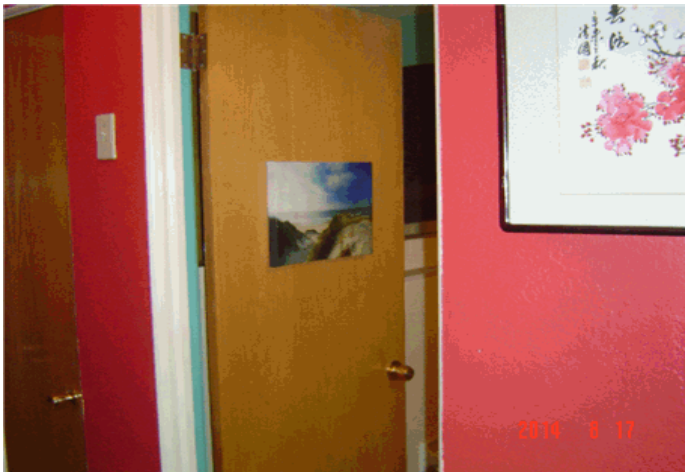
30) Interior Door Conditions

The interior doors appeared to be in serviceable condition at the time of the inspection.

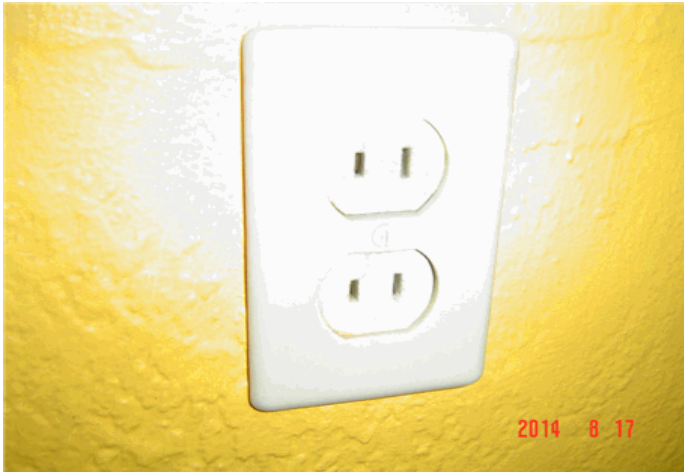
Two prong (non-grounded) receptacles were observed. Although these were commonly used years ago, we recommend a licensed electrician upgrade to grounded three prong receptacles.

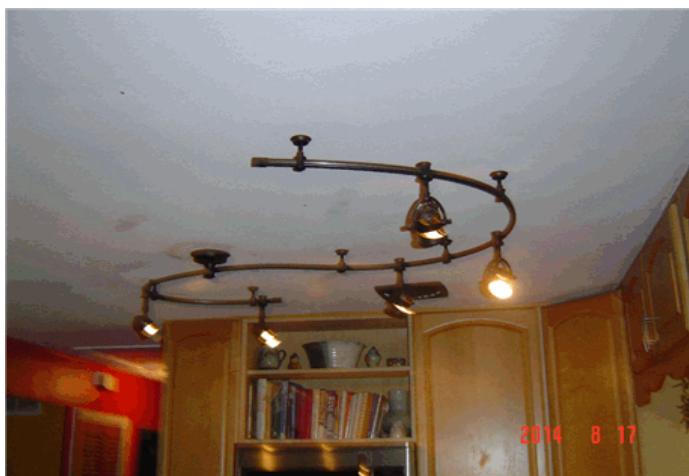
The general condition of the ceilings appeared to be in serviceable condition at the time of the inspection.

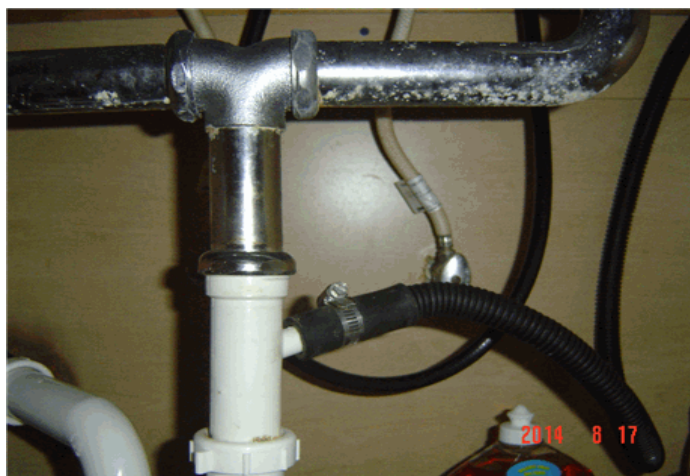
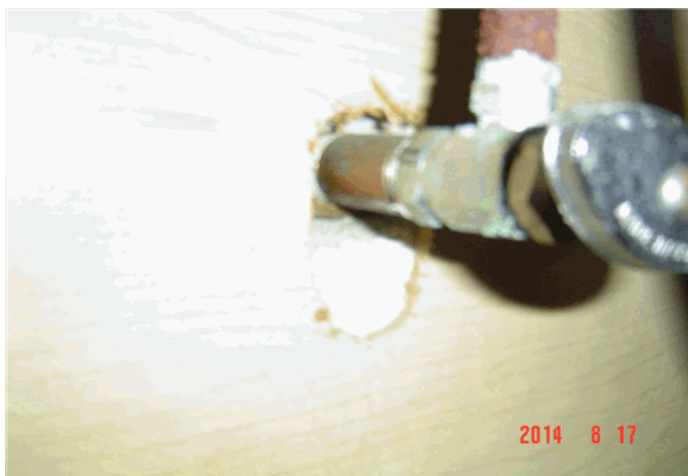
43) Sink Plumbing Conditions**AS**

The kitchen sink appeared to be in serviceable condition at the time of the inspection. The faucet appeared to be in serviceable condition at the time of the inspection. The visible areas of the plumbing under the kitchen sink appeared to be in serviceable condition at the time of the inspection.

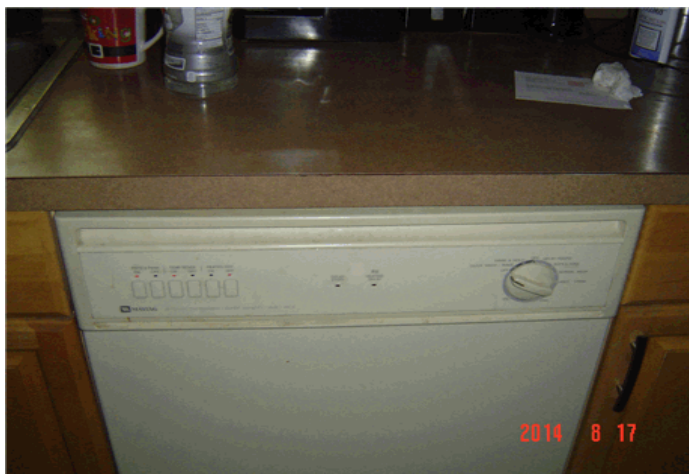
The dishwasher appeared to be in serviceable condition at the time of the inspection. This does not however guarantee future performance or conditions.

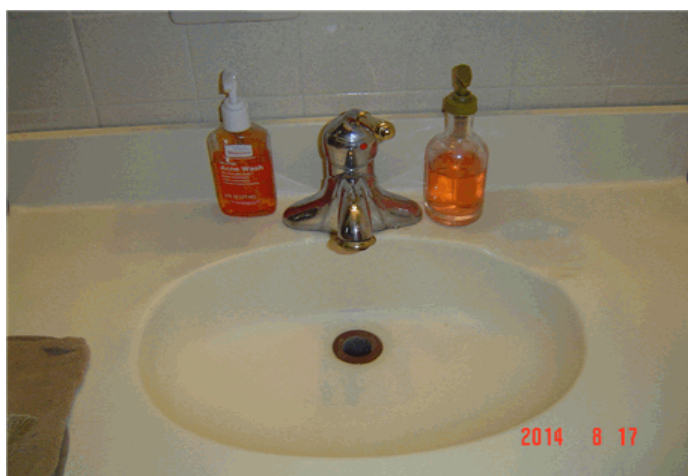
**56) Sink Conditions****AS**

The sink appeared to be in serviceable condition at the time of inspection in bath

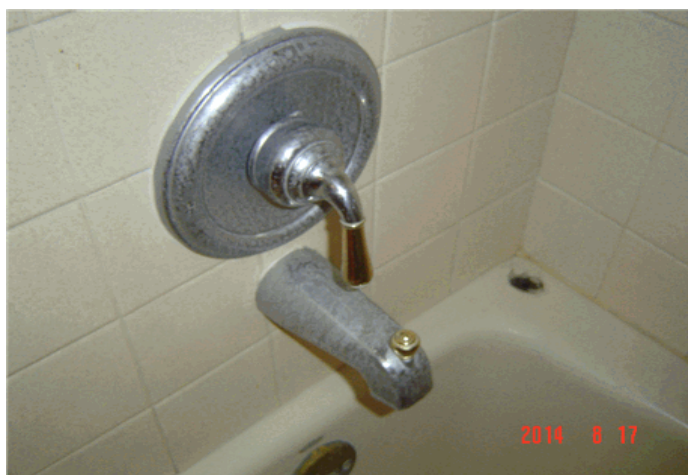
Shower - Tub - Toilet**57) Shower - Tub Conditions****AS**

The bathtub, faucet, and drains appeared to be in serviceable condition.

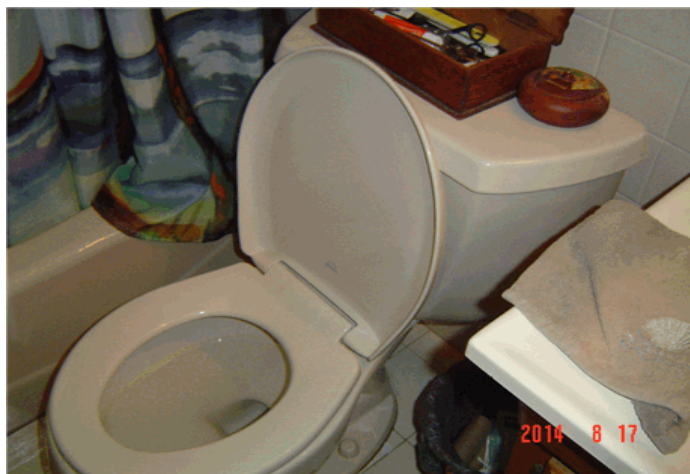
The toilet appeared to be in serviceable condition at the time of inspection in bath

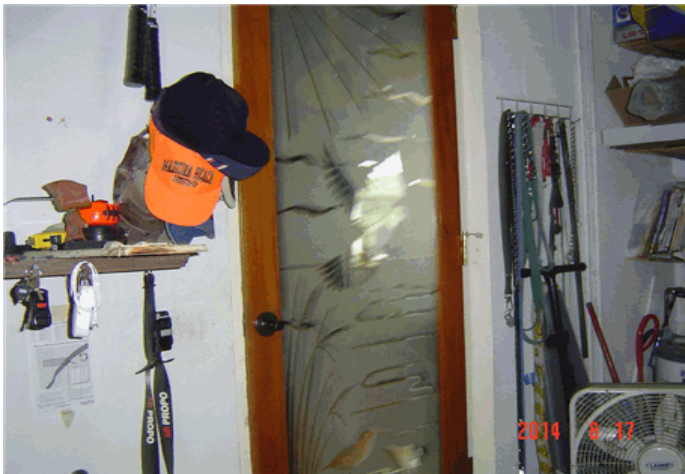
63) Door Conditions

The interior door was a standard hollow interior style door and did not appear to be fire rated. Ideally, a fire rated door should be installed.

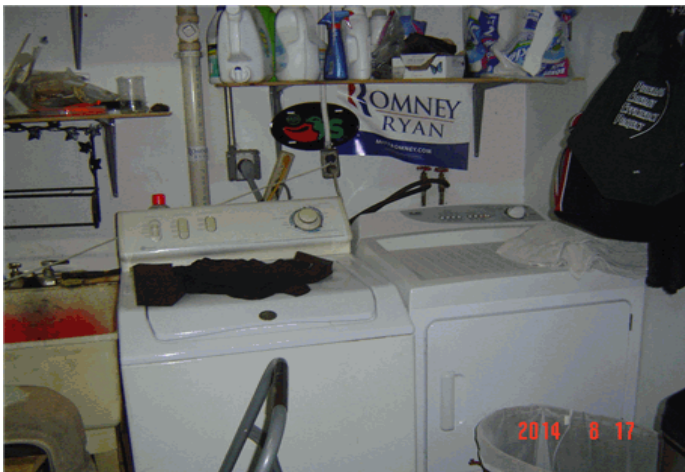
The visible and accessible portions of the laundry plumbing components appeared to be in serviceable condition at the time of inspection.
